## Home Inspection Report

149 Kailors Cove Circle  
Ringgold, GA 30736

**Inspected By:** Michael Teems

**Prepared For:** Emilee Teems  
Inspected on Sat, Jul 26, 2025 at 8:45 AM

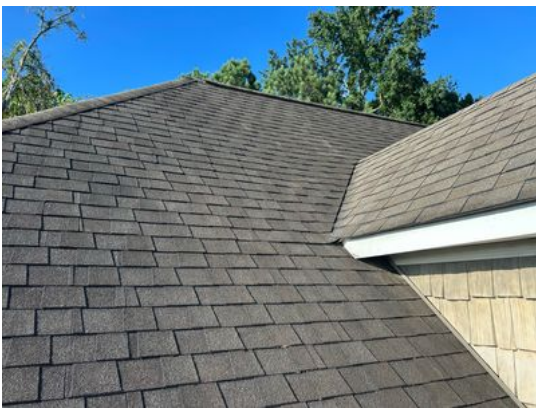
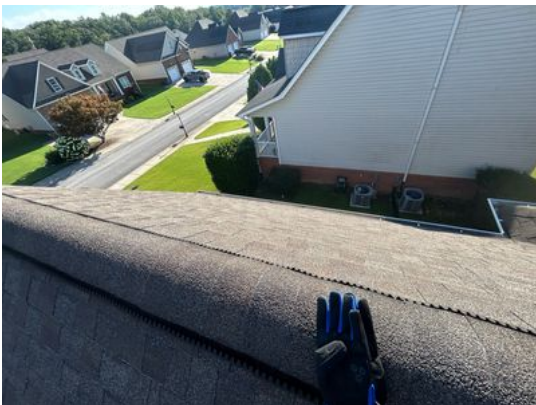
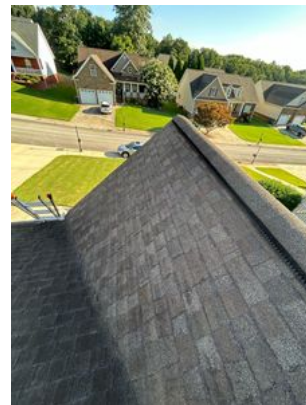
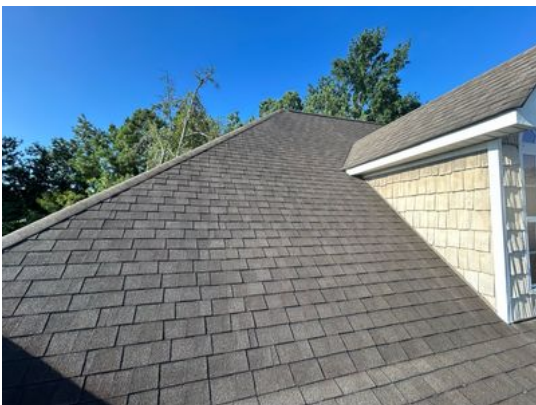
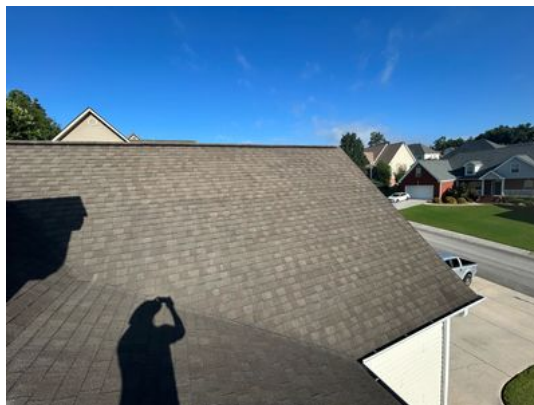
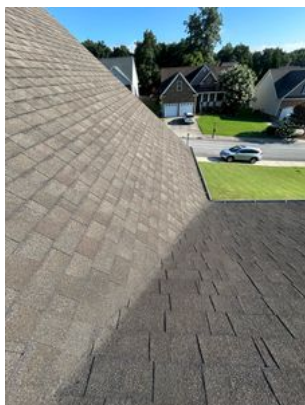
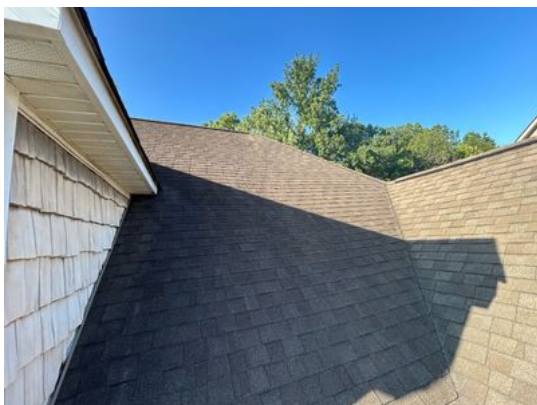
Roof is near end of service life. Noticed granular loss, cupping, frayed edges, hail damage, and brittle shingles. Typical life expectancy of asphalt roof shingles is 20 to 30 years, but this varies based upon several factors such as rain, heat, hail, wind, etc.

Recommend monitoring for active rain leaks and for roof to be replaced by licensed roof contractor when needed.

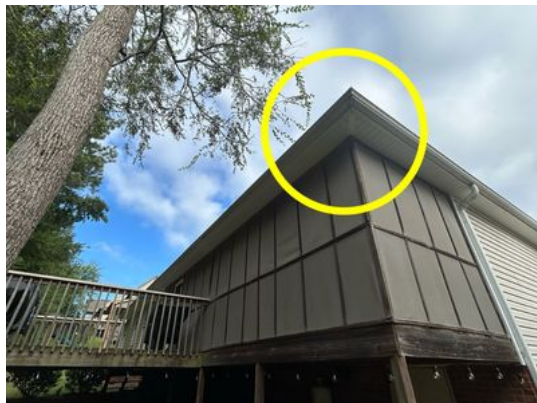
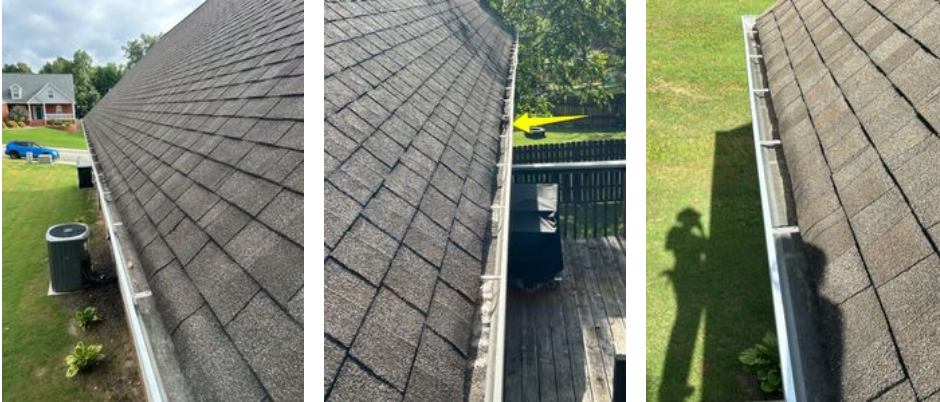
Downspouts were observed to be in position to divert water away from home and foundation. Downspout at walkway will divert water onto walkway and potential slip hazard in colder weather.

Gutters observed to have some debris in them at rear porch of house in area near tree. Regular maintenance will be needed to keep gutters clean in order for water to drain properly. Areas in front and rear gutters showed signs of overflow. This needs to be monitored due to potential for standing water which could flow back into fascia areas.

Gutters may not drain properly due to long lengths at rear of home which looked level and contained only one downspout. Front gutter at porch may not drain properly due to that the gutters looked level, with only one downspout and the changed angle design of gutter.

Recommend review by qualified gutter contractor.

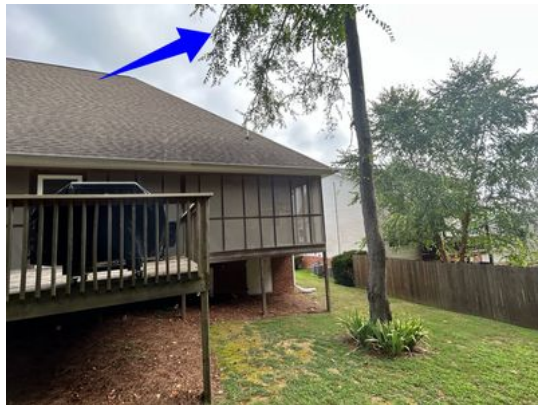
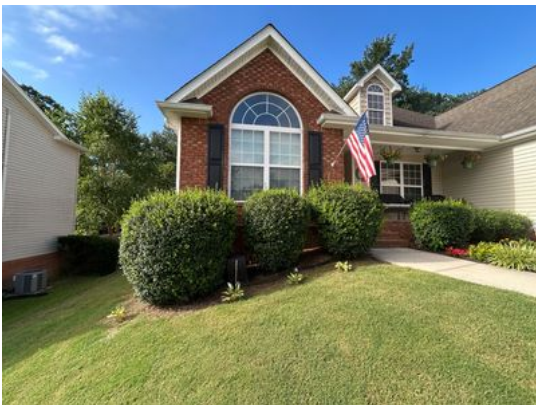
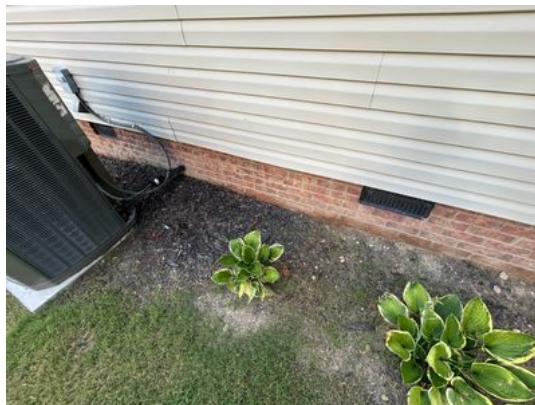
Tree in backyard found to be overhanging roof and should be trimmed to keep branches from falling on house and leaves from clogging gutter.

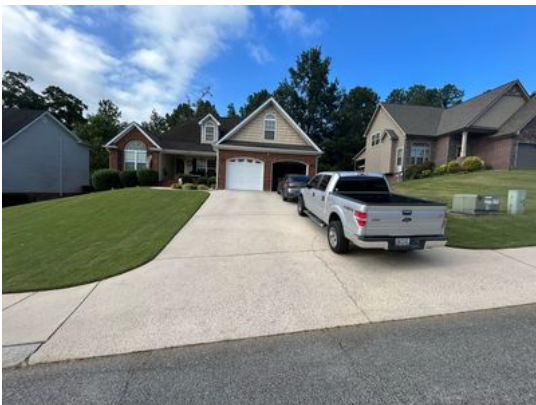
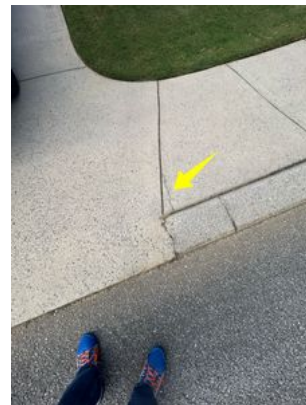
Several cracks were observed in the driveway. Cracks need to be repaired to prevent erosion of soil underneath. Cracks can create uneven surfaces which become trip hazards.

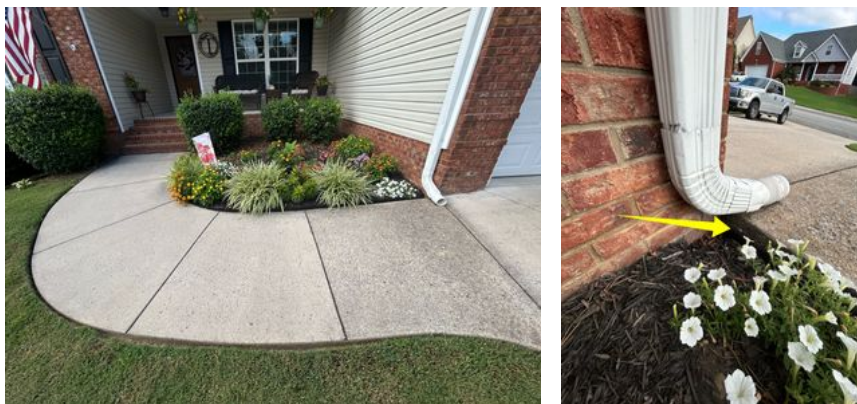
Erosion area noticed at walkway area. Recommend filling area to prevent further erosion and potential issue and cracking with settlement issues in walkway.

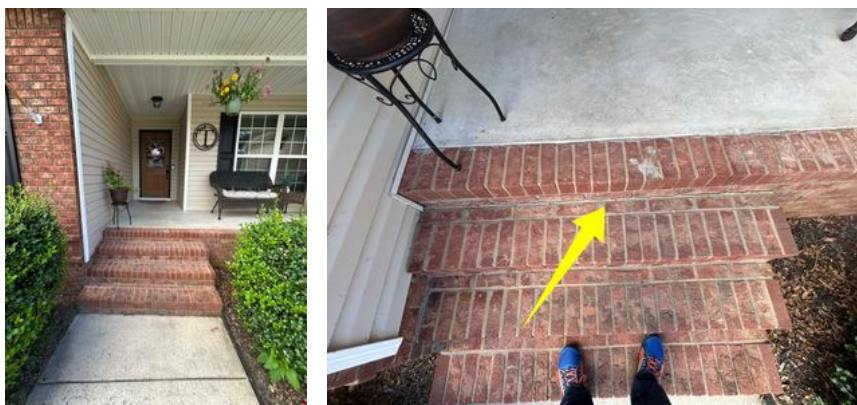
Separation observed between step and front porch. Monitor condition and if separation grows larger, repairs may be needed to prevent weakening of materials in this area.

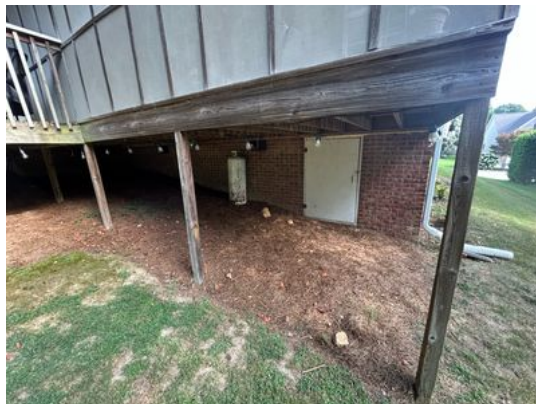
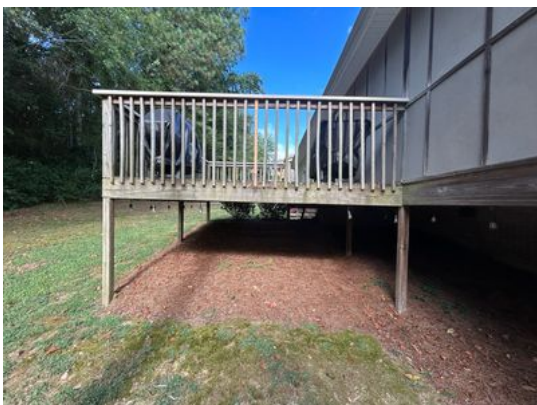
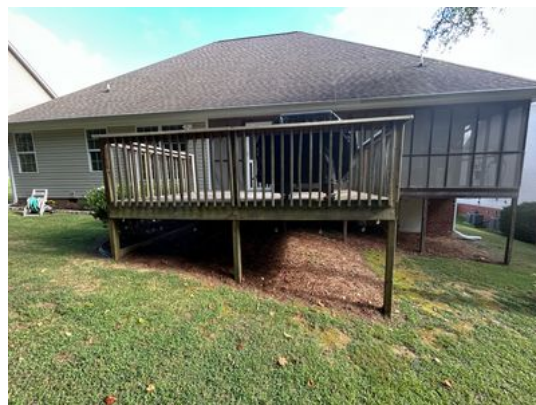
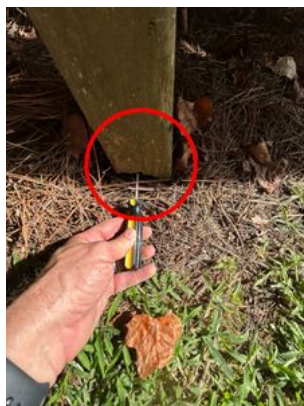
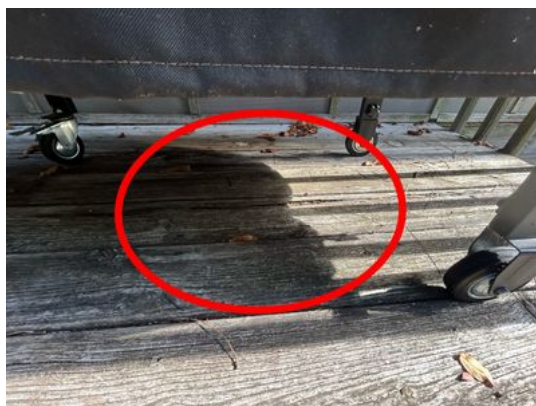
Deck needs to be reviewed by contractor. Several cracks were observed in wood beams and joists. Deck flooring and beam showed rotting wood and missing material. No deck flashing observed at ledger board and rear porch area. Several balusters were found to be loose and unattached.

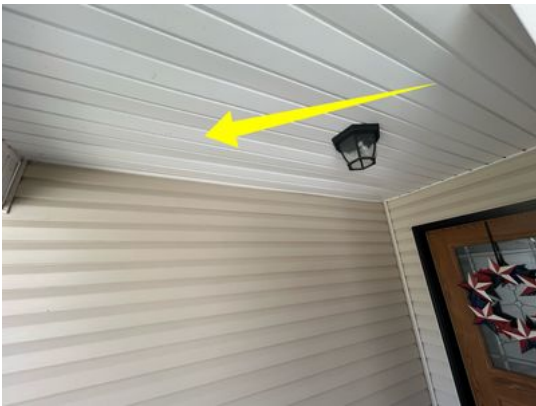
Area above door was observed to be sagging or uneven. Recommend review and correction by qualified handyman.

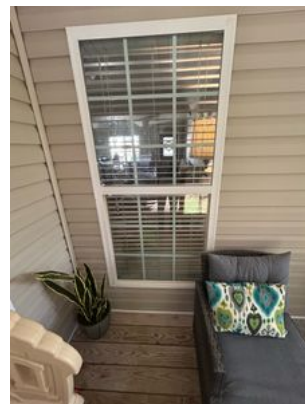
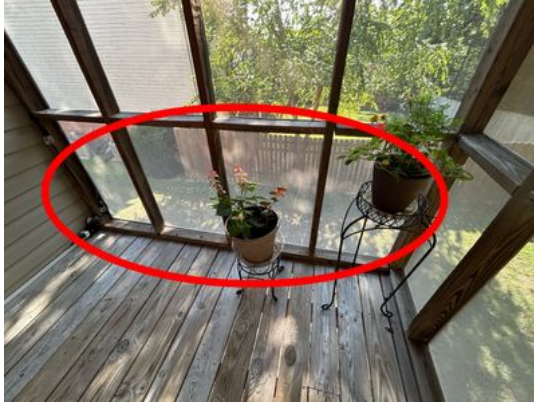
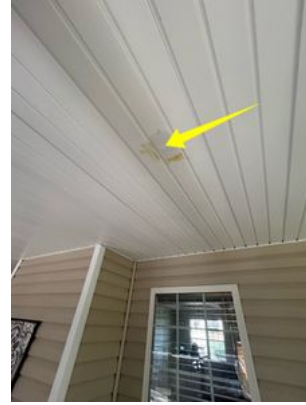
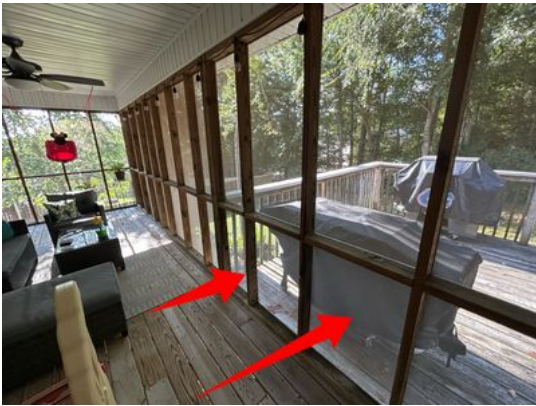
No balusters were observed but only screening. This is safety concern and needs to be evaluated and repaired by certified or licensed contractor to prevent someone from falling through screen.

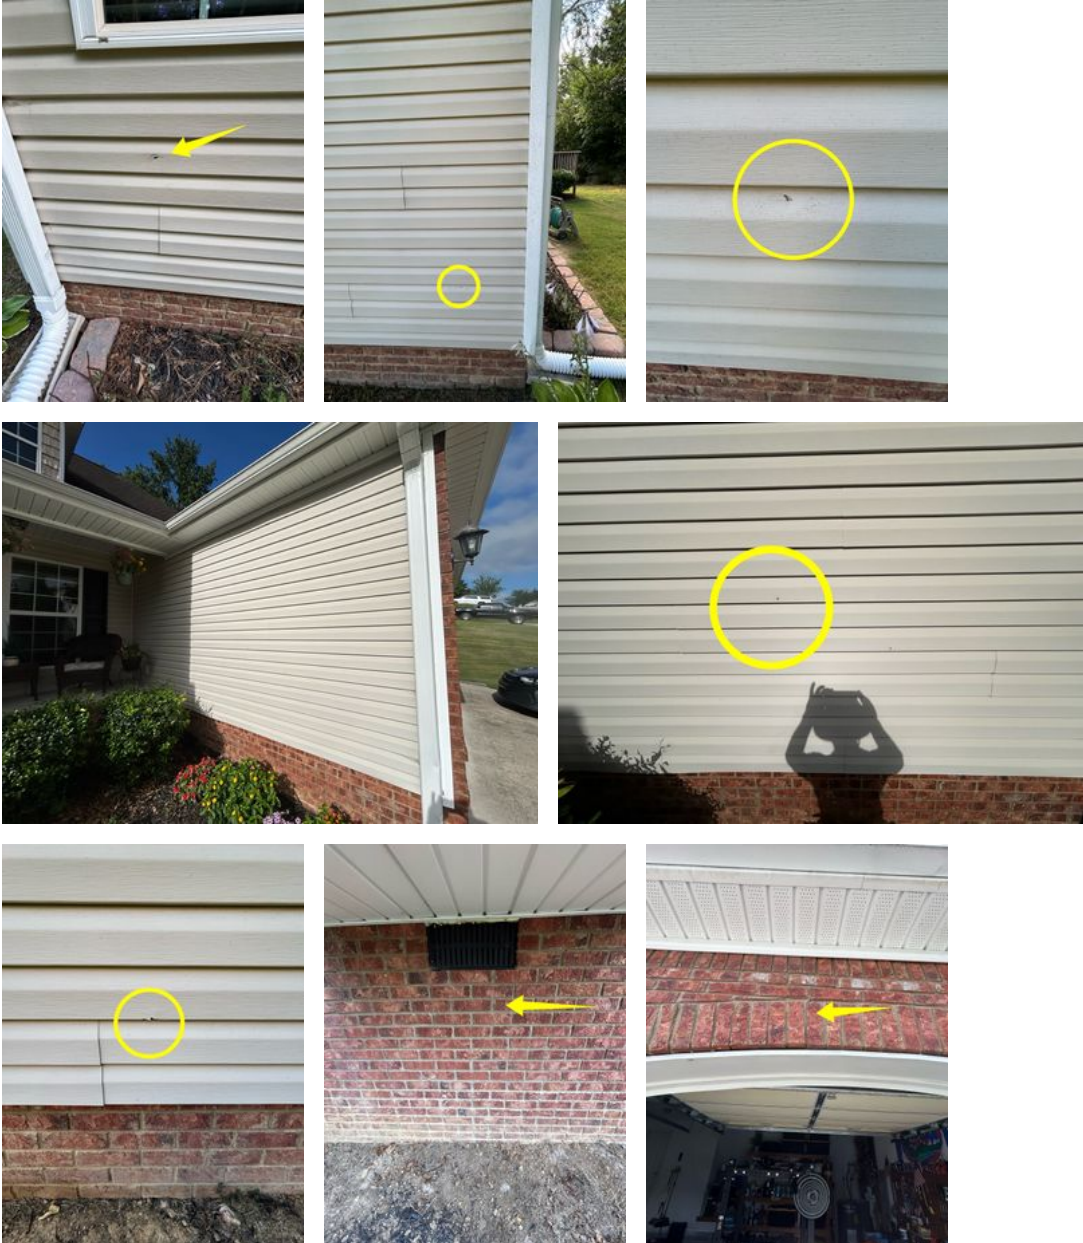
Various holes were observed in vinyl siding along perimeter of home. Recommend repairs to these areas to prevent water intrusion.

Some small cracks were observed in bricks at foundation on left side of home below the foundation vent. Additional cracking noticed above garage door. Recommend areas be monitored and if cracks spread and grow larger that areas be reviewed by Structural Engineer.

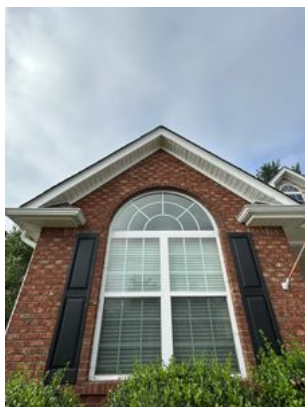
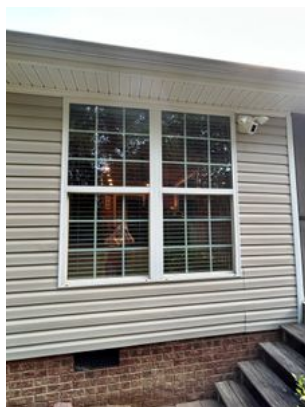
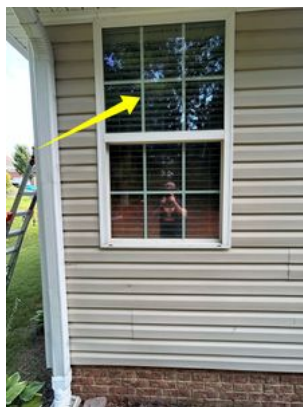
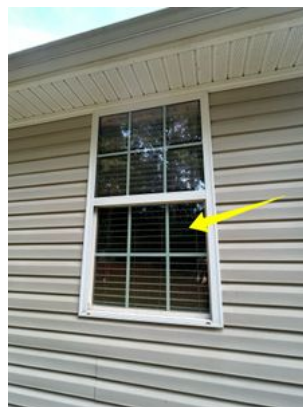
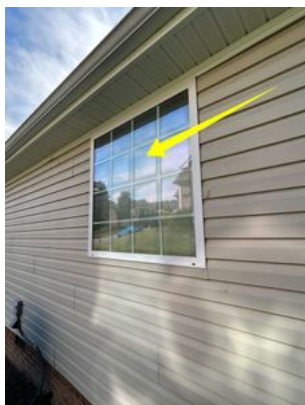
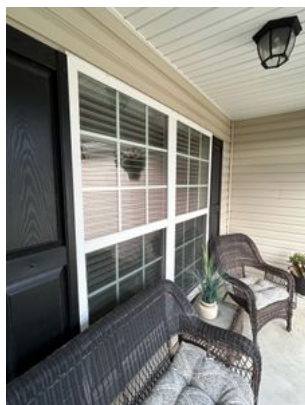
Windows in master bedroom and master bathroom showed signs of hematic seal issues. Windows operated as intended. Upgrade to energy efficient windows recommended option if replacement is desired.

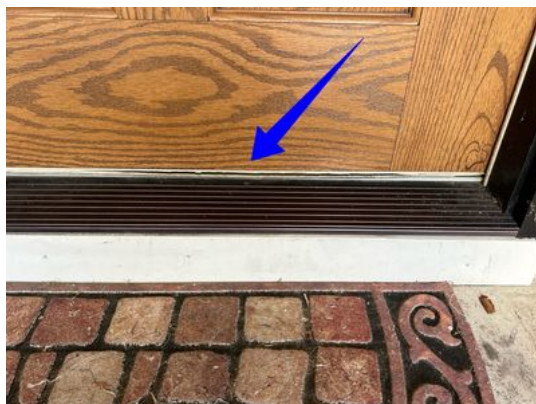
Front door seal found to be worn and in need of replacement. Recommend new seal be installed by qualified handyman in order to prevent air entering and leaving home.

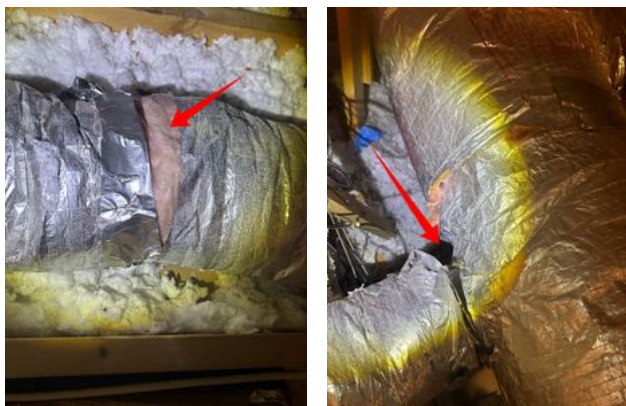
During inspection of attic, it was observed that several air ductwork connections were not sealed off properly. Recommend review and correction by certified HVAC technician.

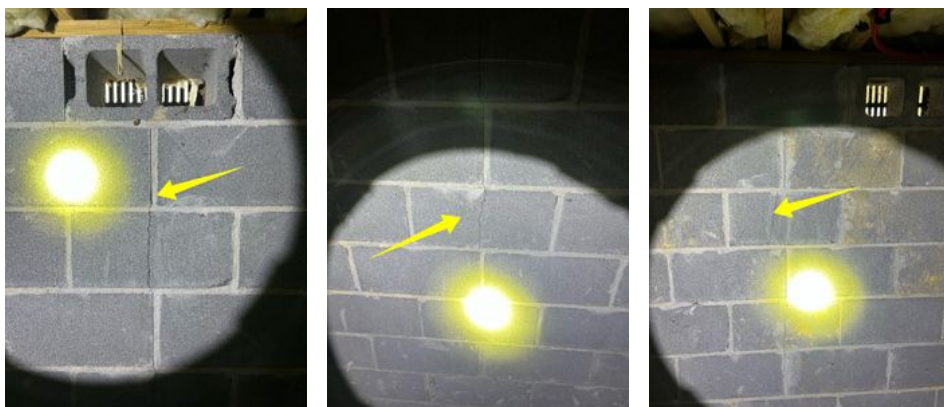
Cracks were observed on left side wall between vent areas. Recommend further evaluation of area by structural engineer.

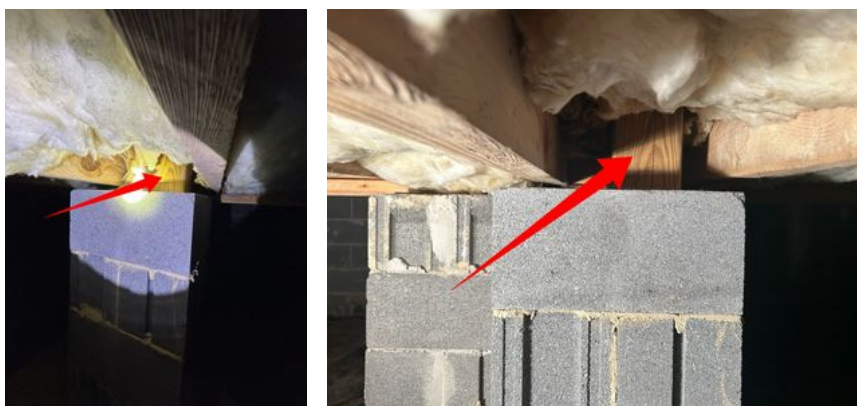
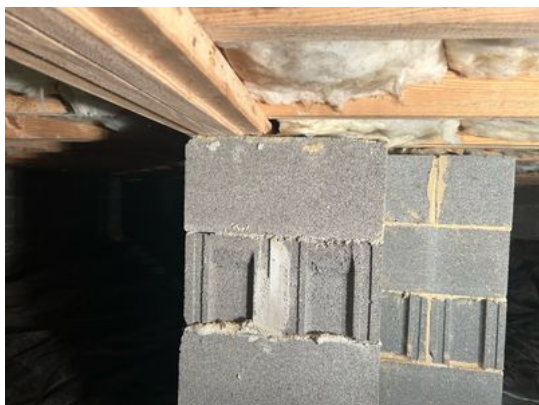
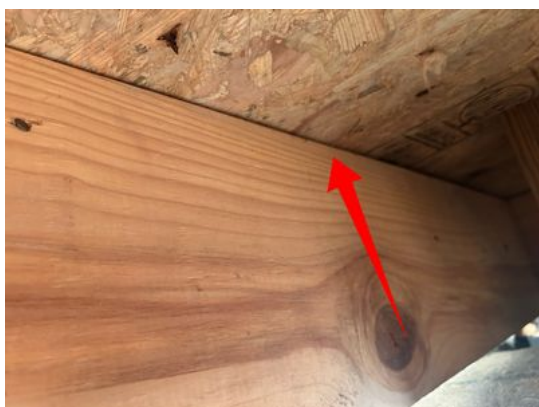
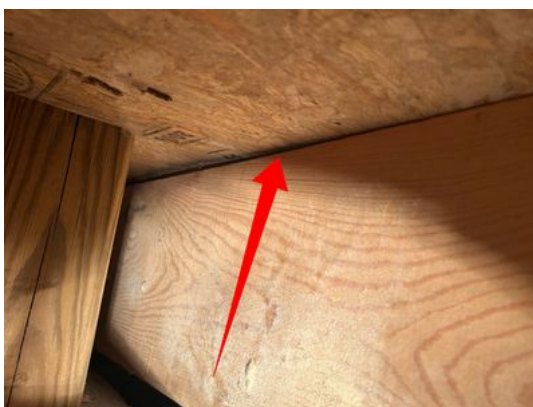
Pier located below kitchen nook area found to have support on top of pier making direct contact with floor sheathing. Recommend further evaluation from structural engineer.

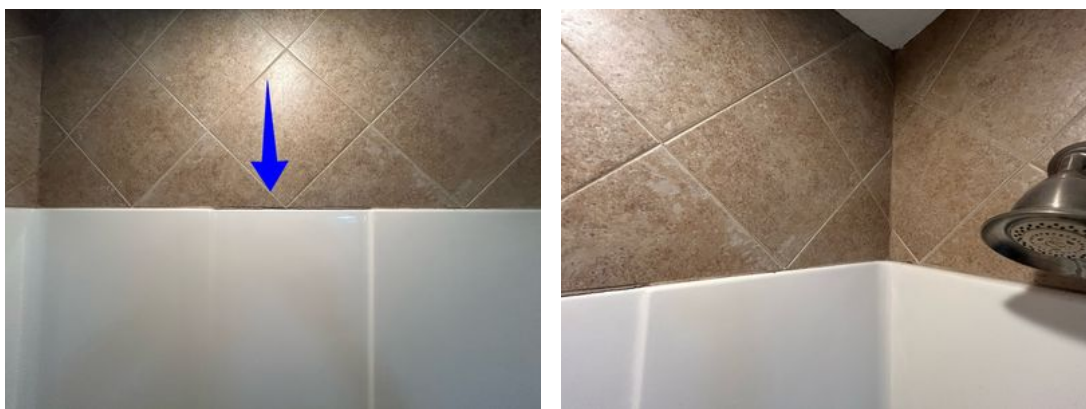
Area between shower and tile found to have small gaps. Recommend that this area be sealed to prevent water intrusion in these areas by qualified handyman.

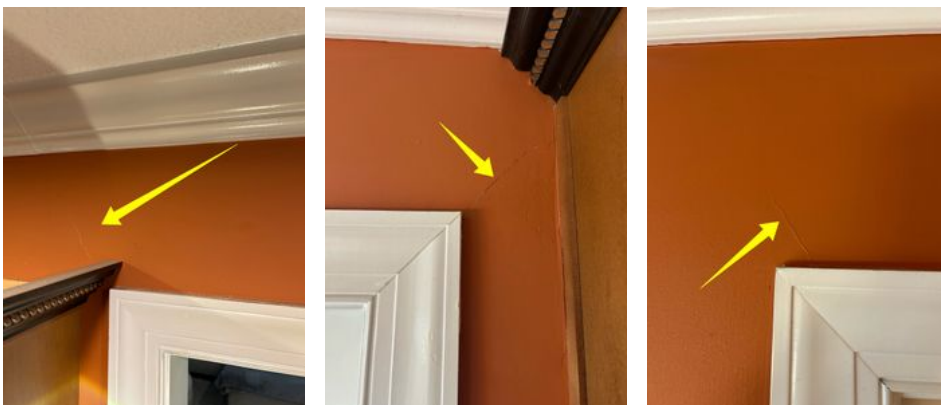
Noticeable cracks observed over door that led to master bedroom. Additional crack noticed above cabinet located near bar area. Recommend further evaluation from Structural Engineer due to conditions noticed with kitchen floor not being level.

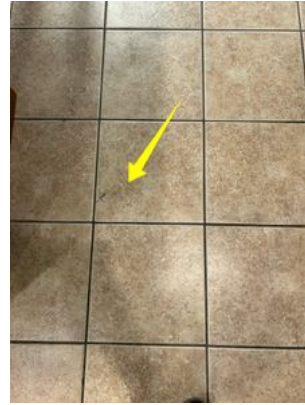
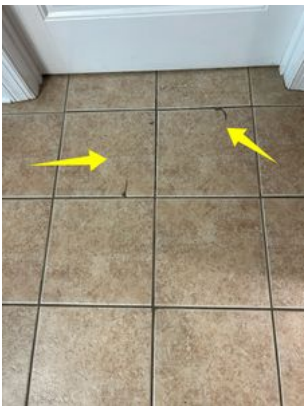
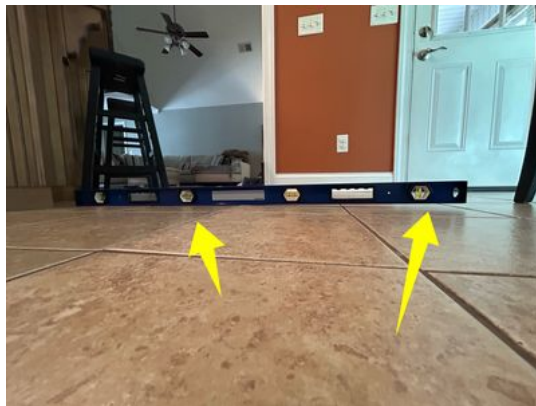
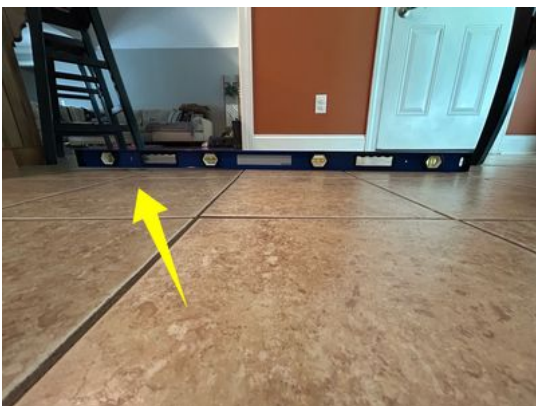
Noticeable cracks observed in various areas of kitchen floor. Floor shows not to be level in kitchen nook area. Further evaluation recommended from Structural Engineer.

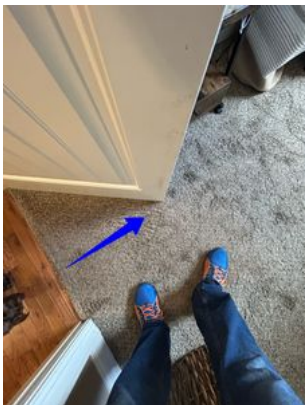
Door dragged on carpet. Door should move freely. Recommend door be adjusted by licensed contractor.

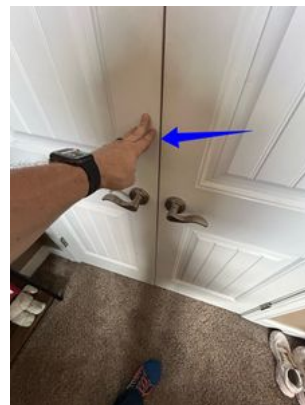
Closet door didn't close properly. Recommend repair by qualified handyman.

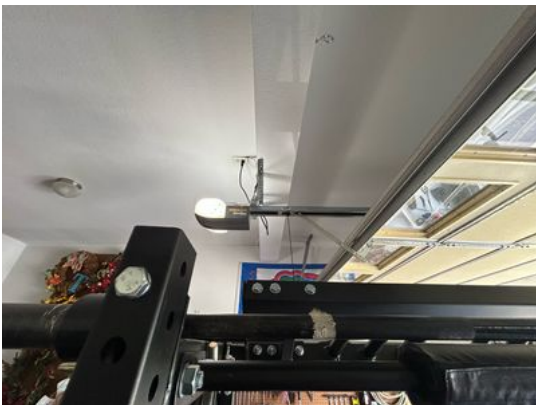
Both garage door tracks were mounted to the drywall. Recommend best practice is not mount to drywall, but rather to solid ledger board.

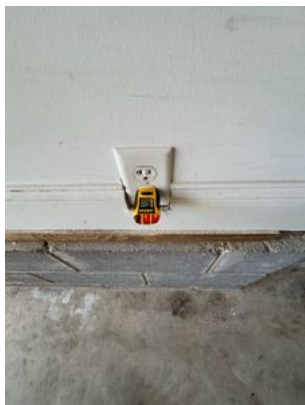
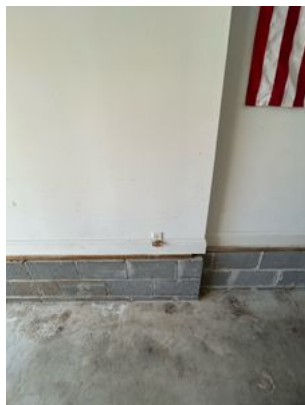
Receptacles located in garage were not GFCI receptacles. Recommend upgrading receptacles to GFCI receptacles.

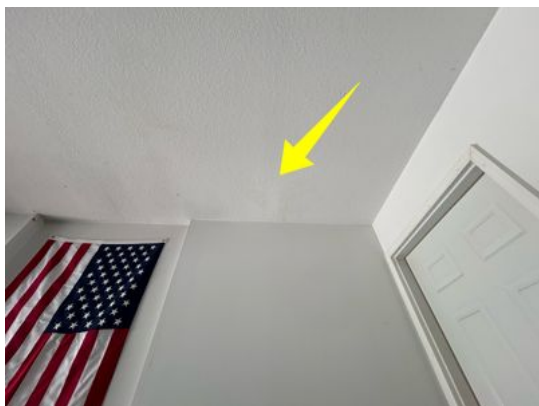
Discolored area observed on ceiling. Area reviewed with moisture meter with no active water leak detected. Recommend monitoring area and asking seller of any known past leaks in this area.

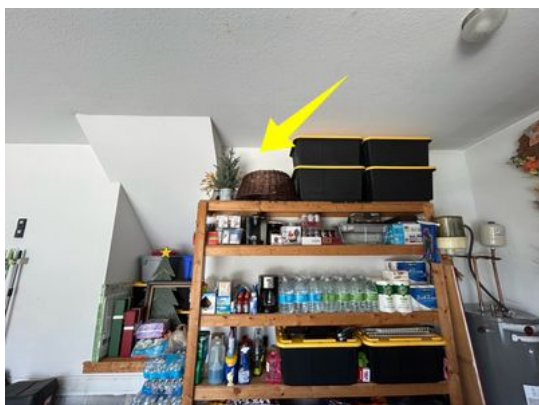
Carbon monoxide detector present but blocked by items on top shelf. Recommend that area detector be free from obstructions.

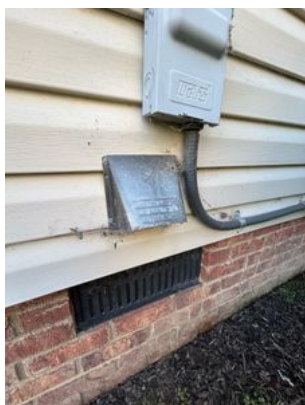
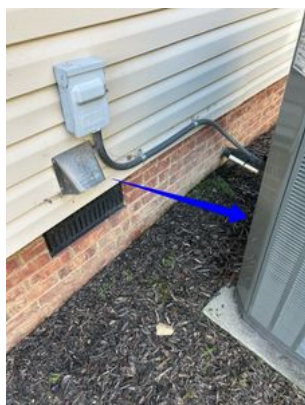
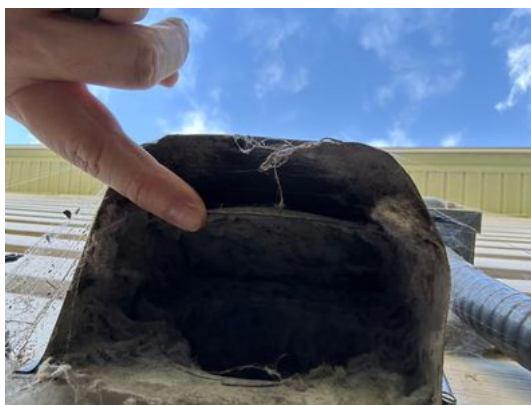
Dryer duct area seemed to be tight but flex duct seemed excessive. Recommend review by licensed contractor to reduce ductwork and possible restricted flow. Excessive lint observed behind dryer, recommend cleaning and verify duct is secured to dryer.
