Mock Inspection Report

67 Squirrel Circle, Ringgold, GA, USA

Nov 16, 2024

This is a mock inspection report to demonstrate that the inspector has performed an inspection according to the [InterNACHI® Standards of Practice](#).

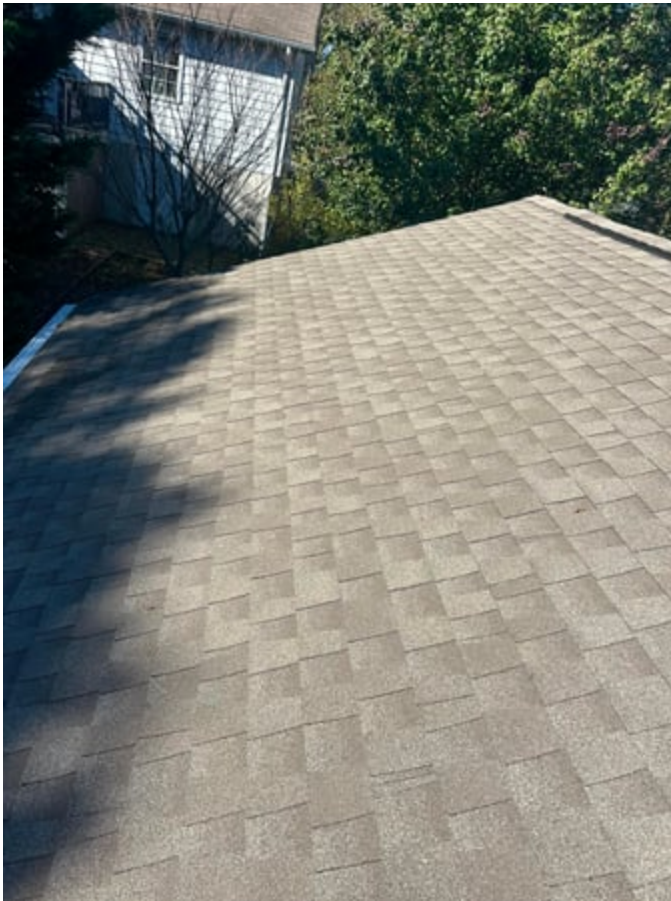
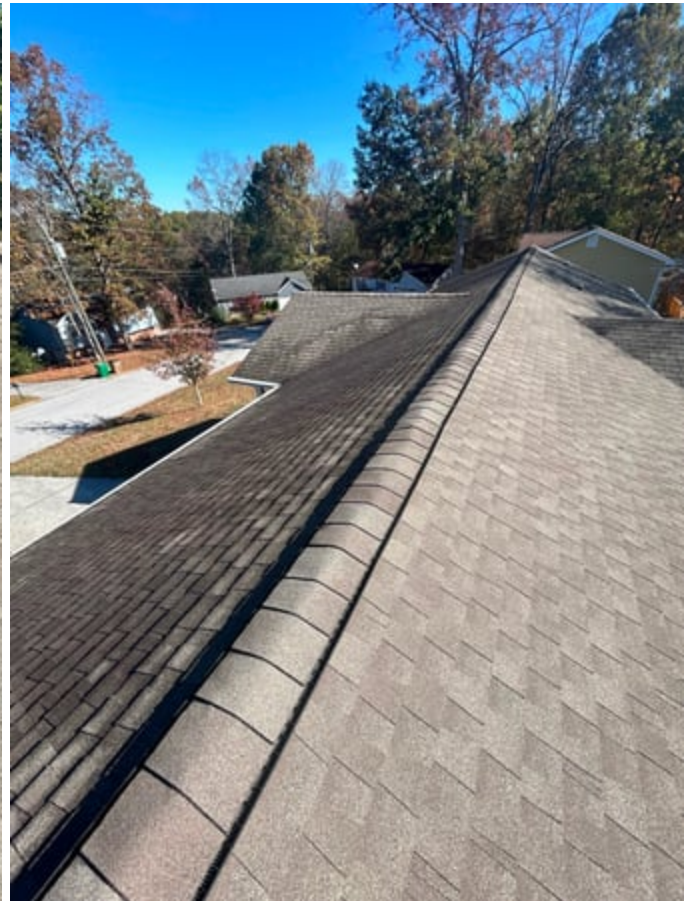
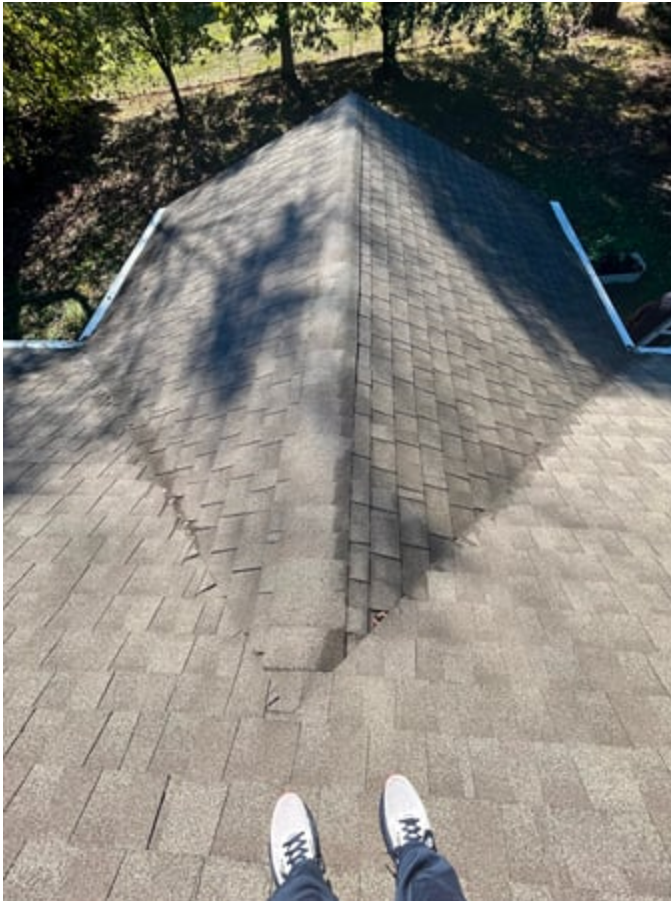
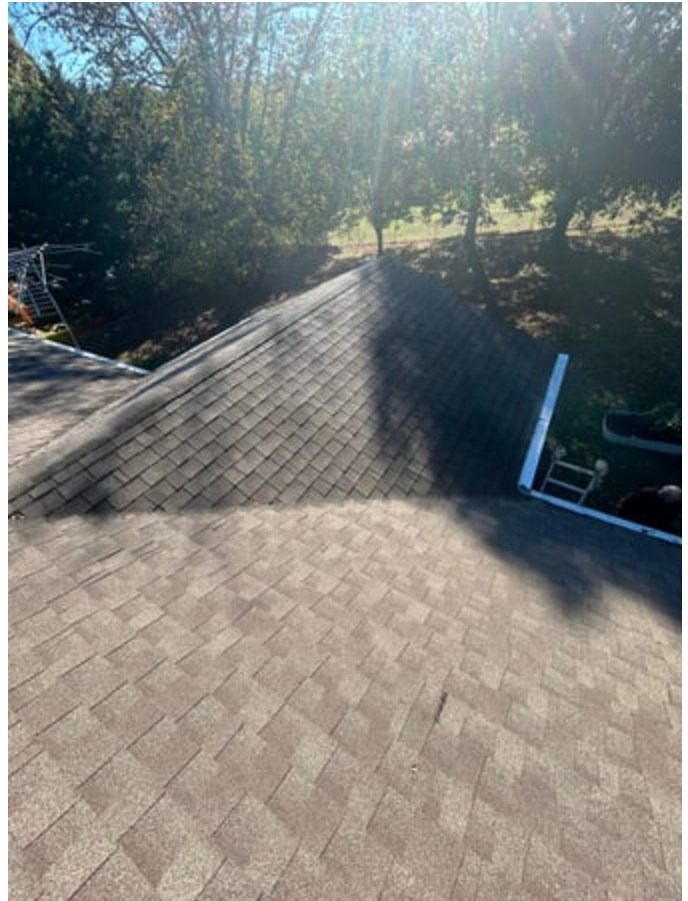
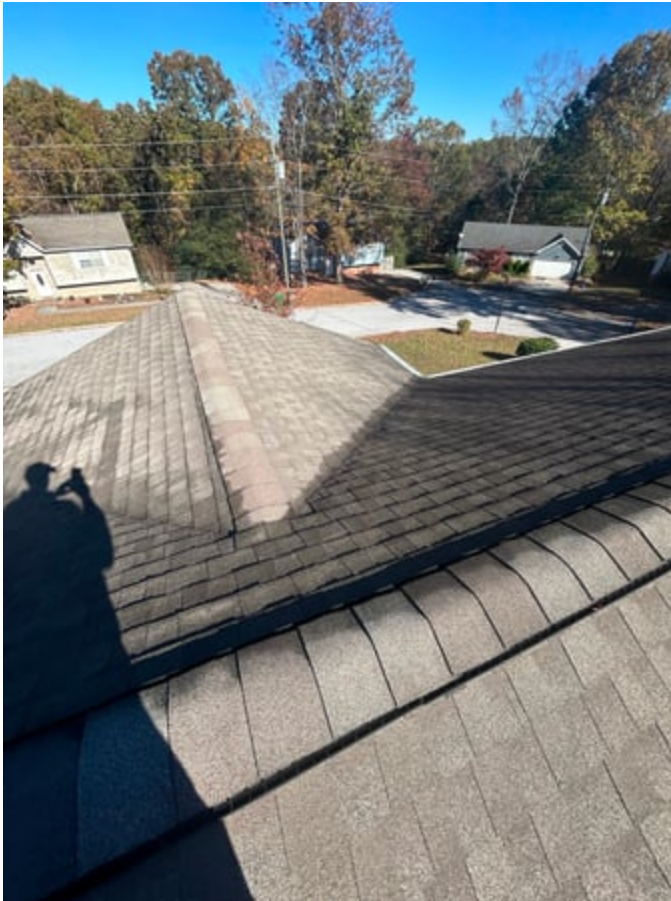
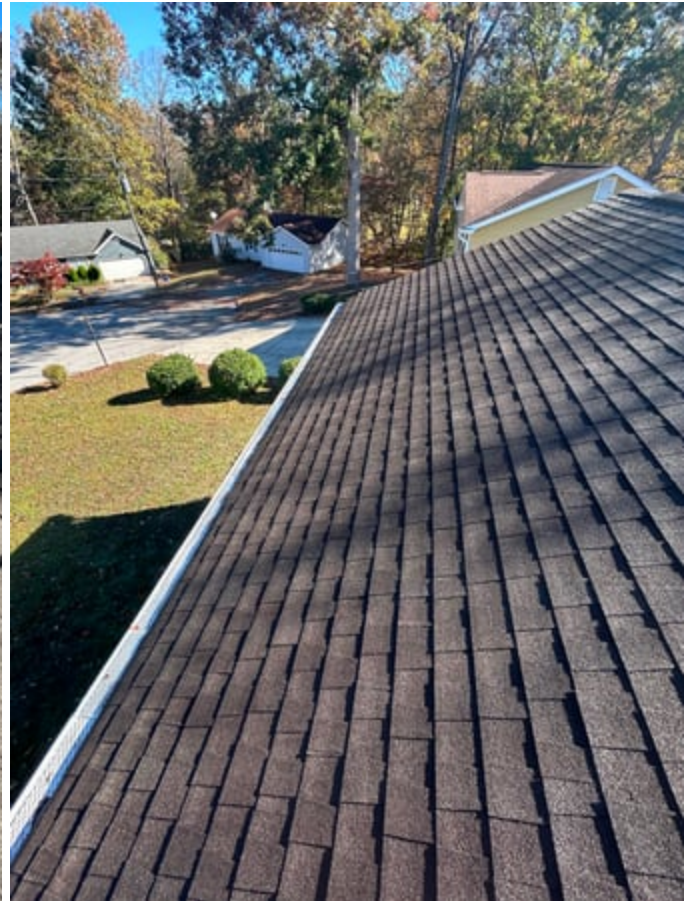
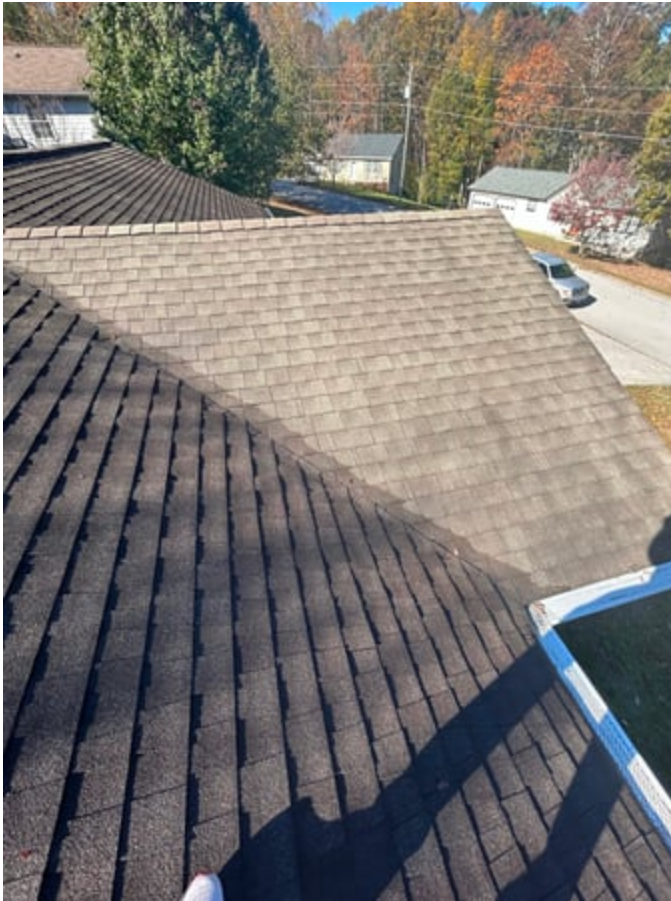
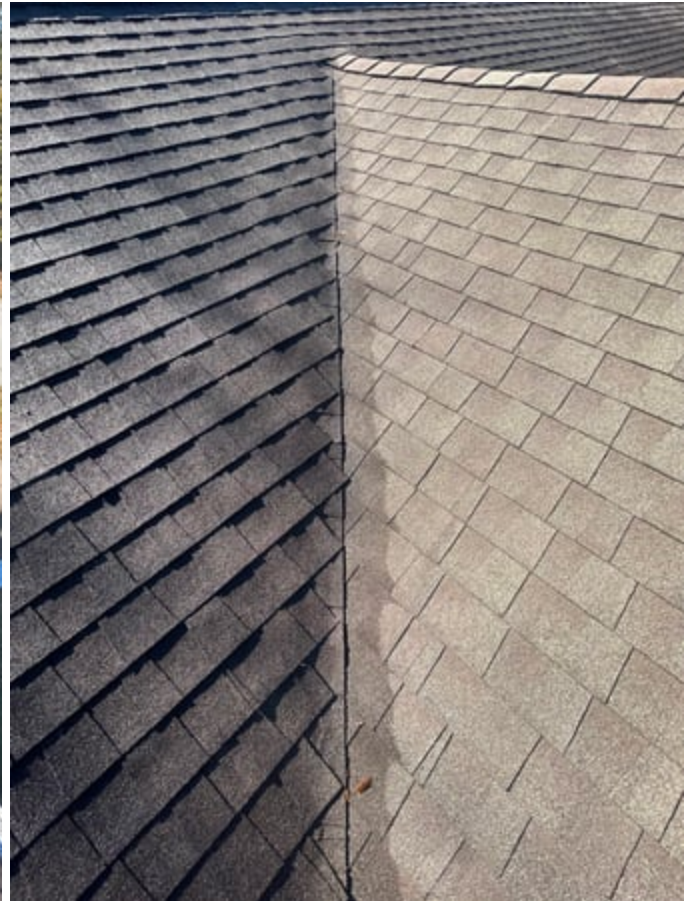
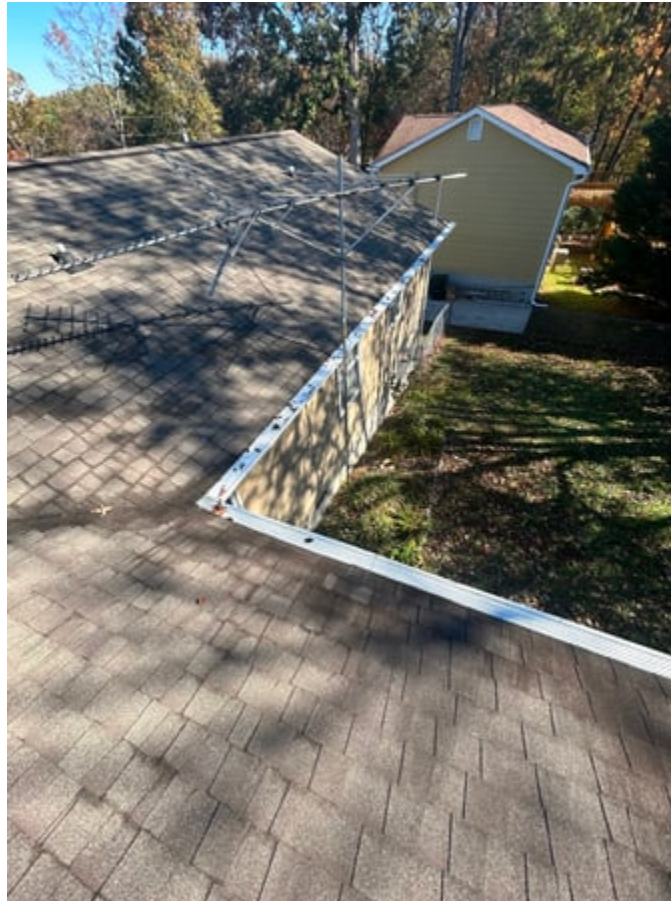
Roof-Covering Materials

The roof was inspected and no defects were found with the roofing material which were architectural asphalt shingles.

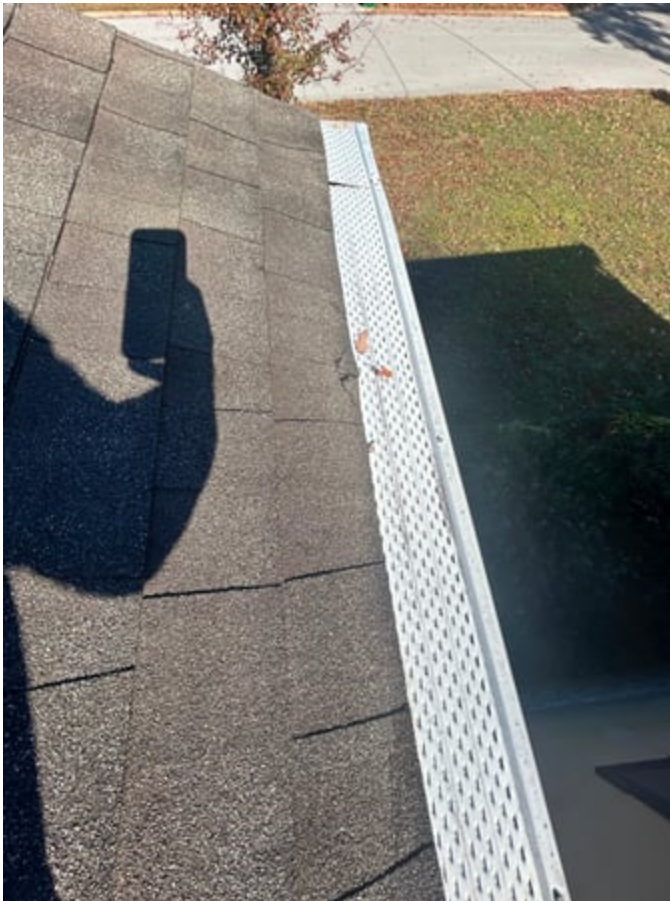
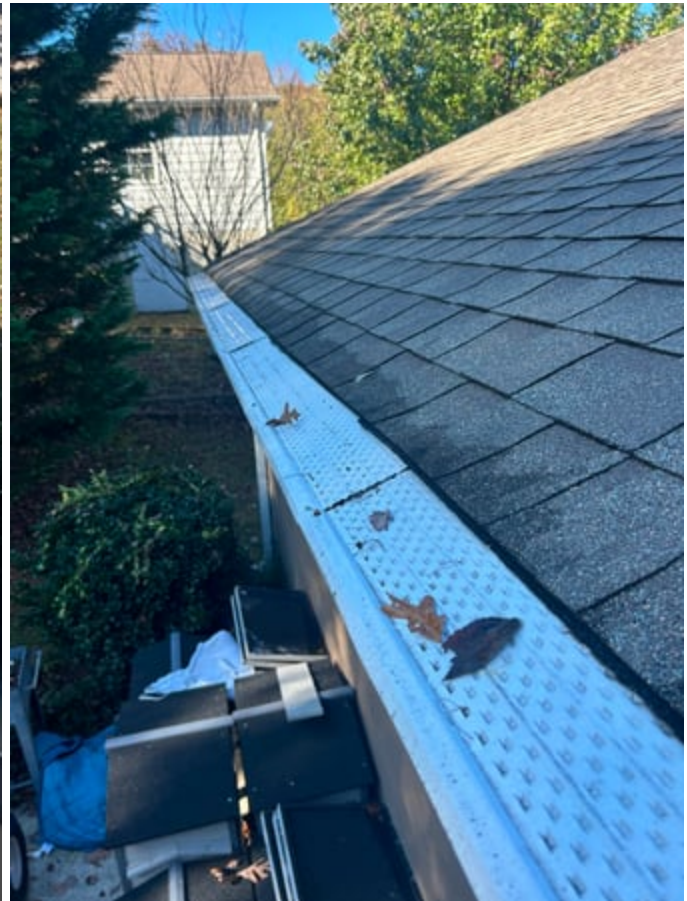
The homes gutters were inspected with no defects found. Gutters contained gutter guards.

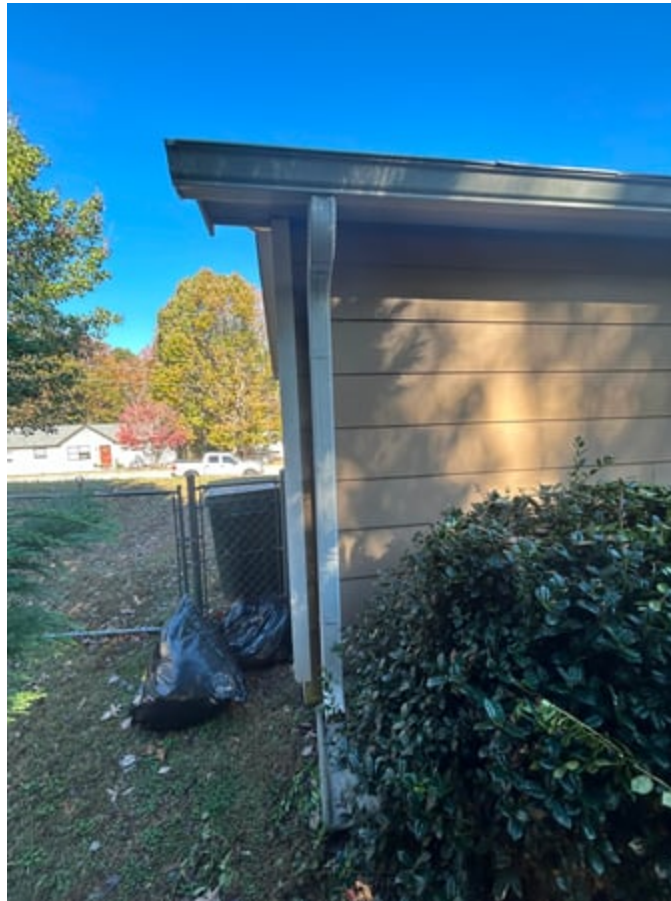
Downspouts were inspected and found to have splash guards.
Recommend gutter extensions to direct water further away from home.

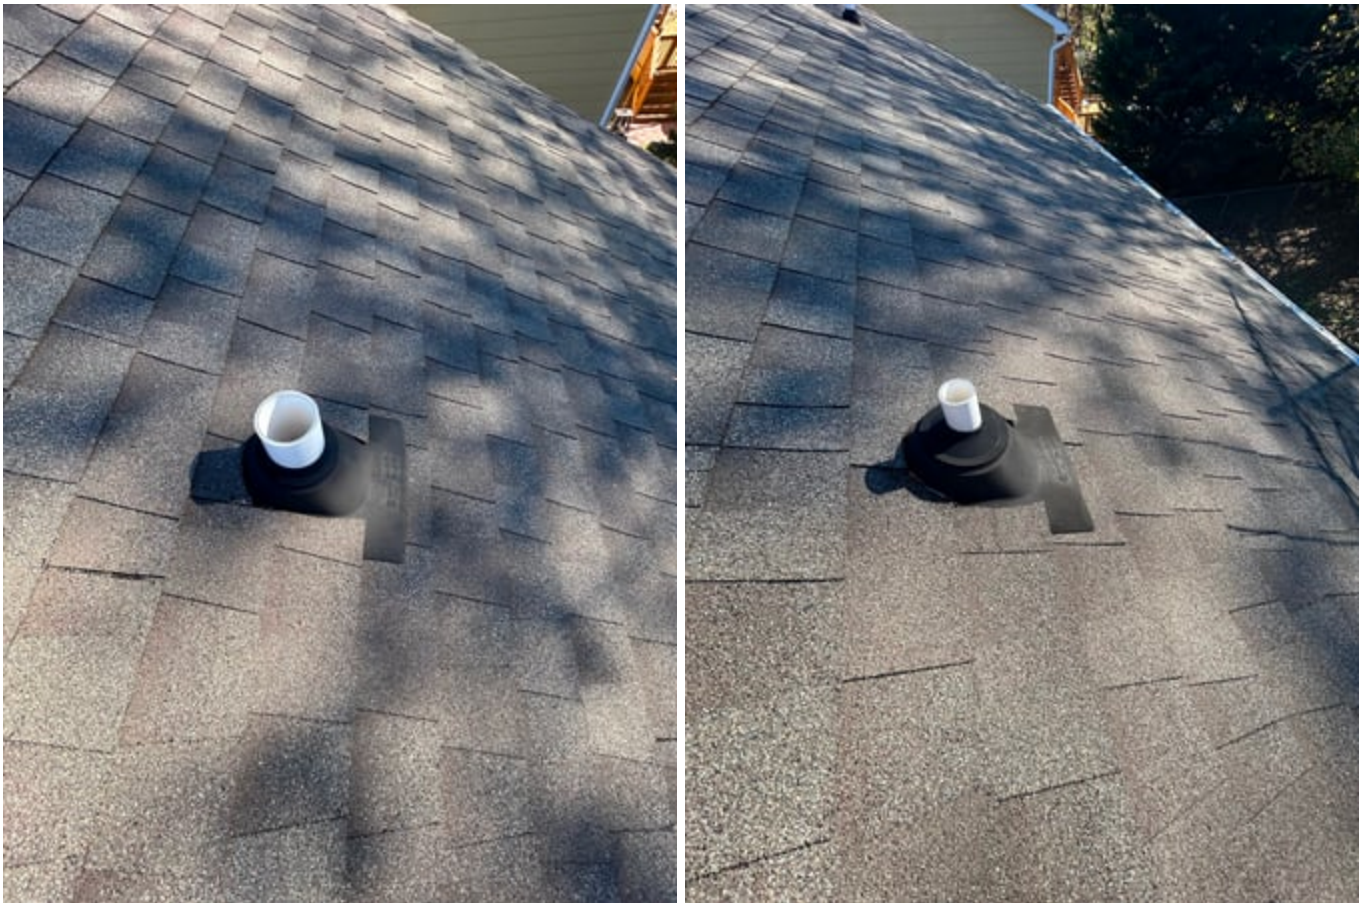
Vents, Flashing, Skylights, Chimney, and Other Roof Penetrations

Roof penetrations were inspected and found to be less than 6 inches above surface.

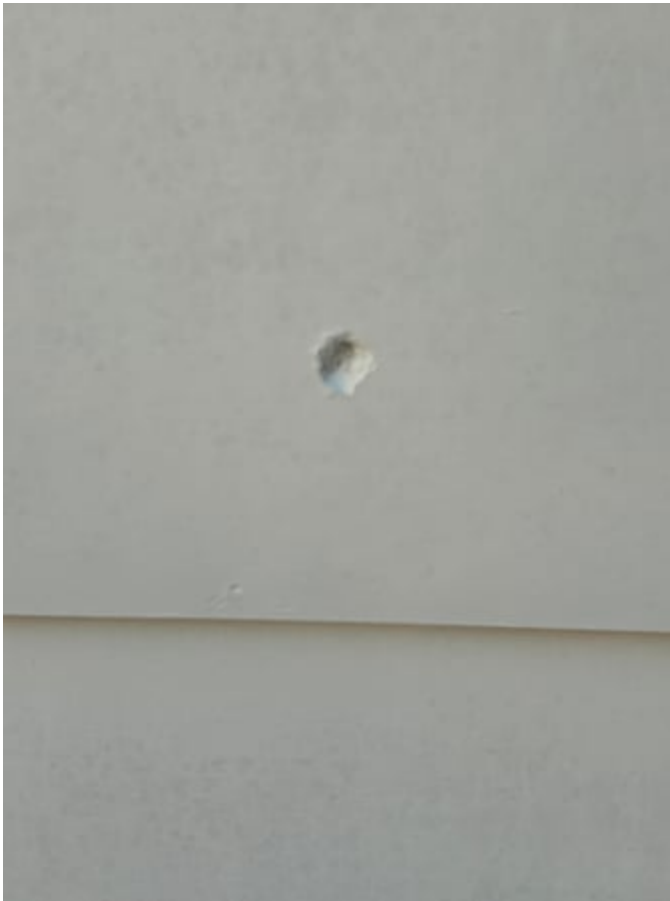
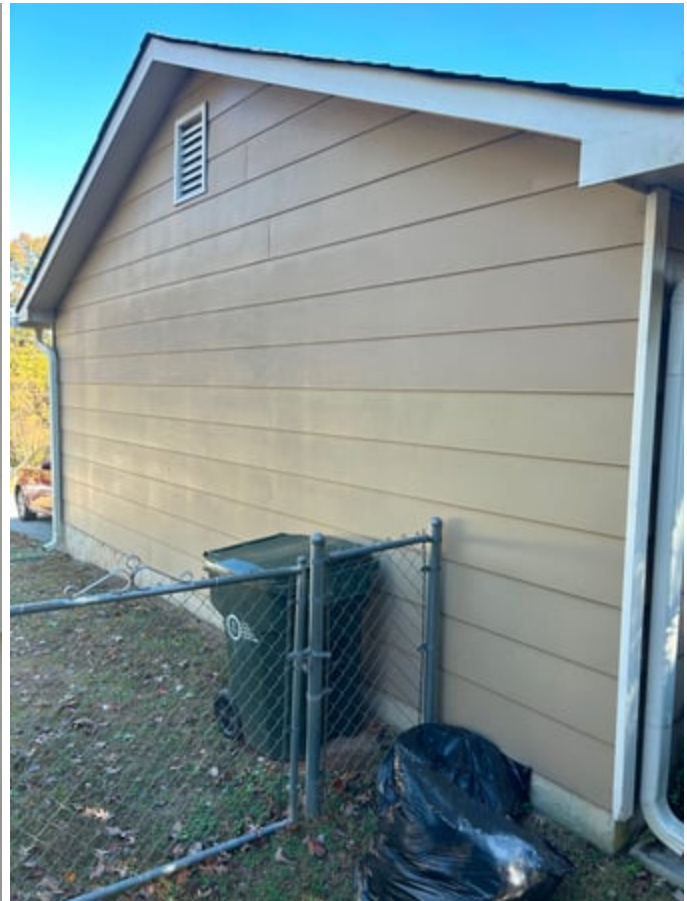
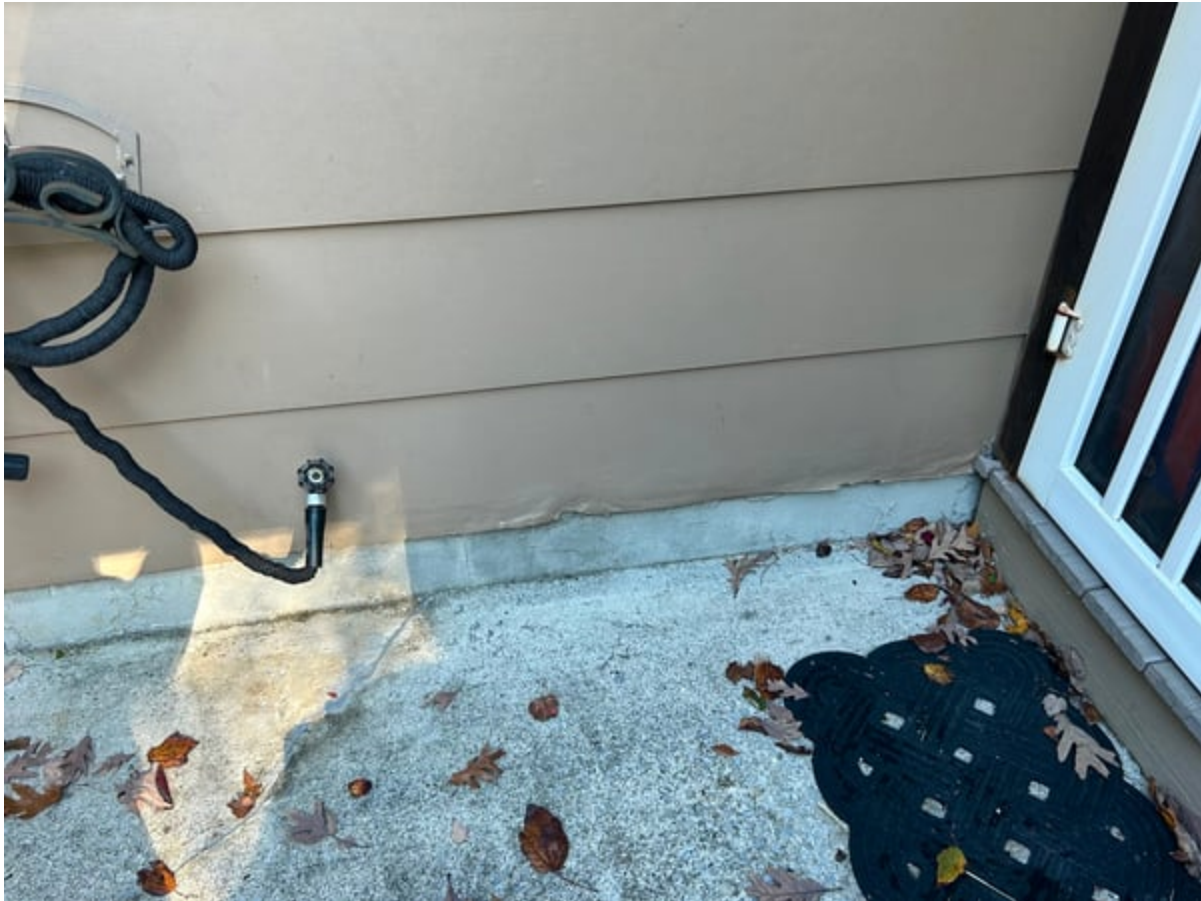
Exterior Wall-Covering Materials

The siding inspected was found to be original siding and contained areas that showed waviness, water damage and cosmetic issues.

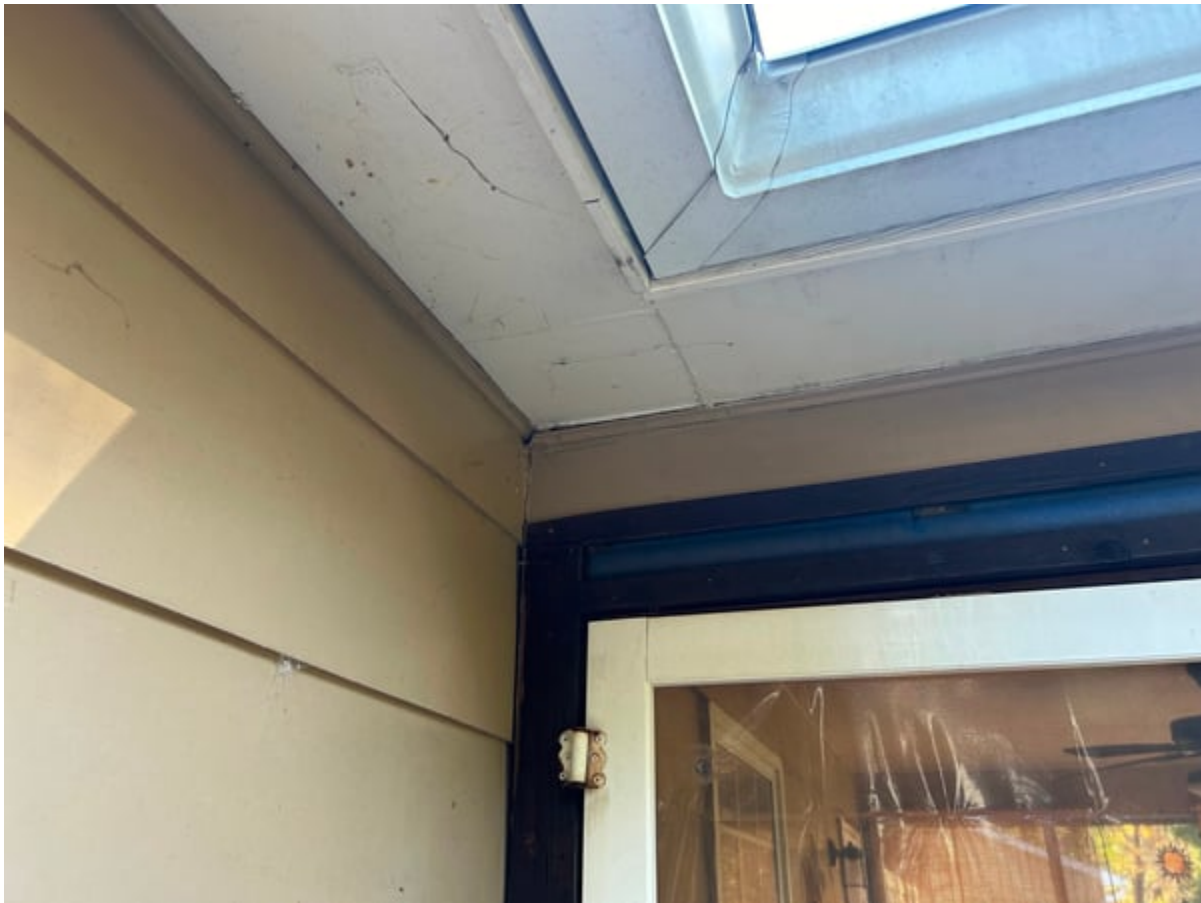
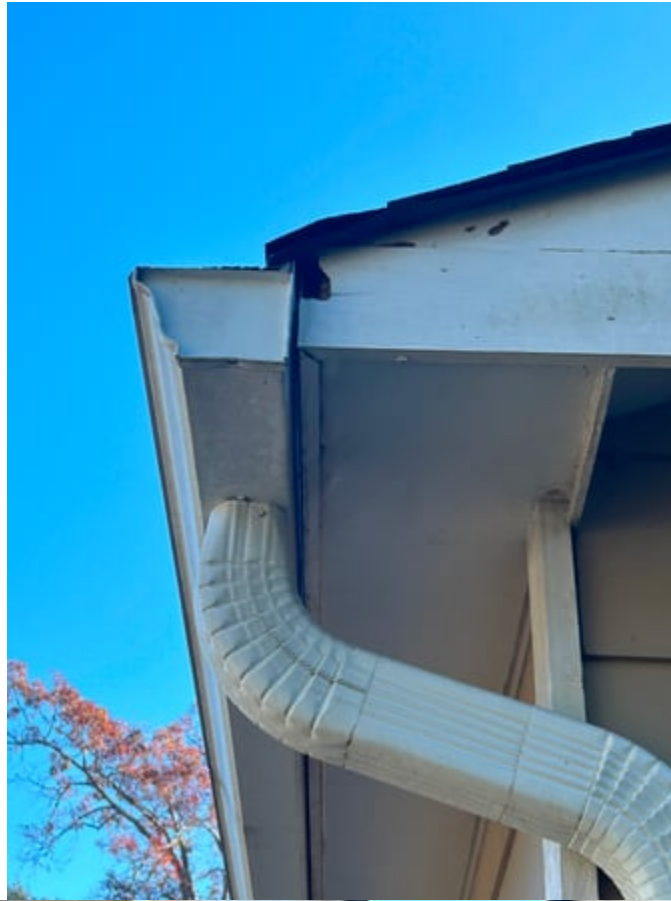
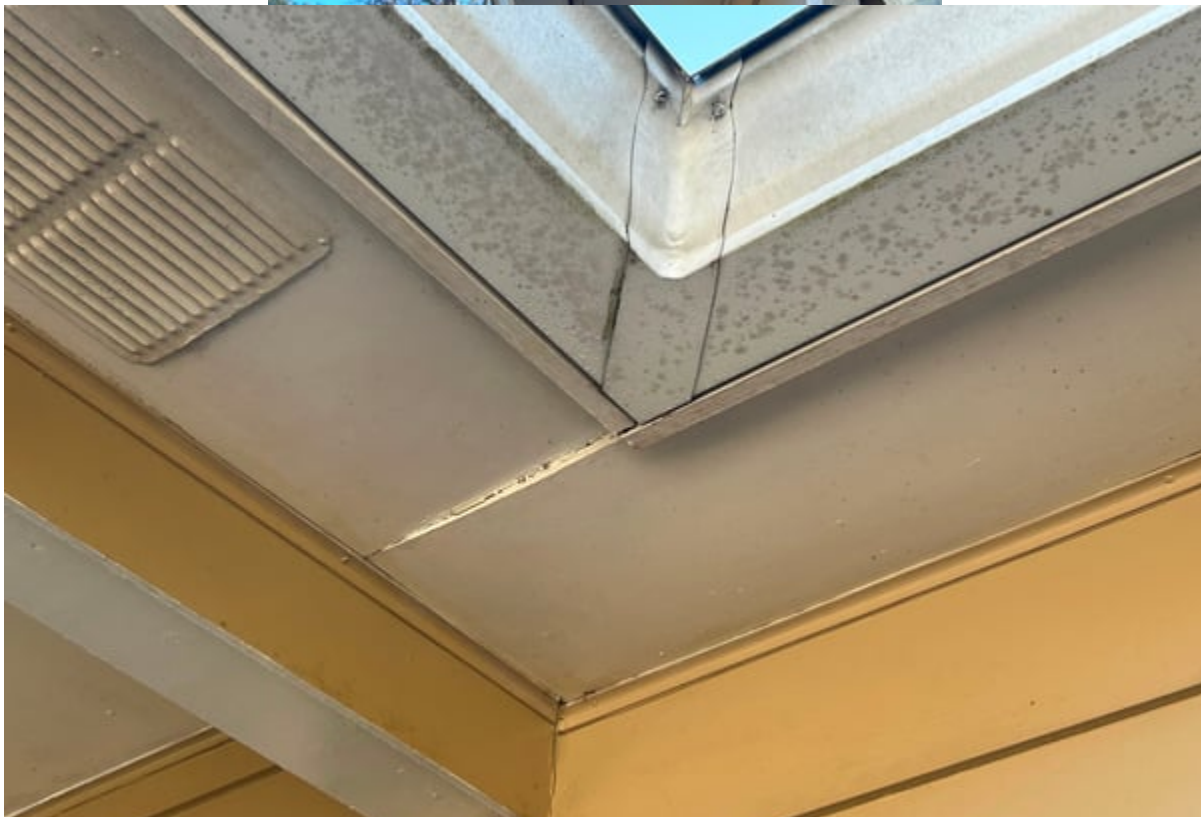
Eaves, Soffits and Fascia

There were several areas noted with missing material and damage.

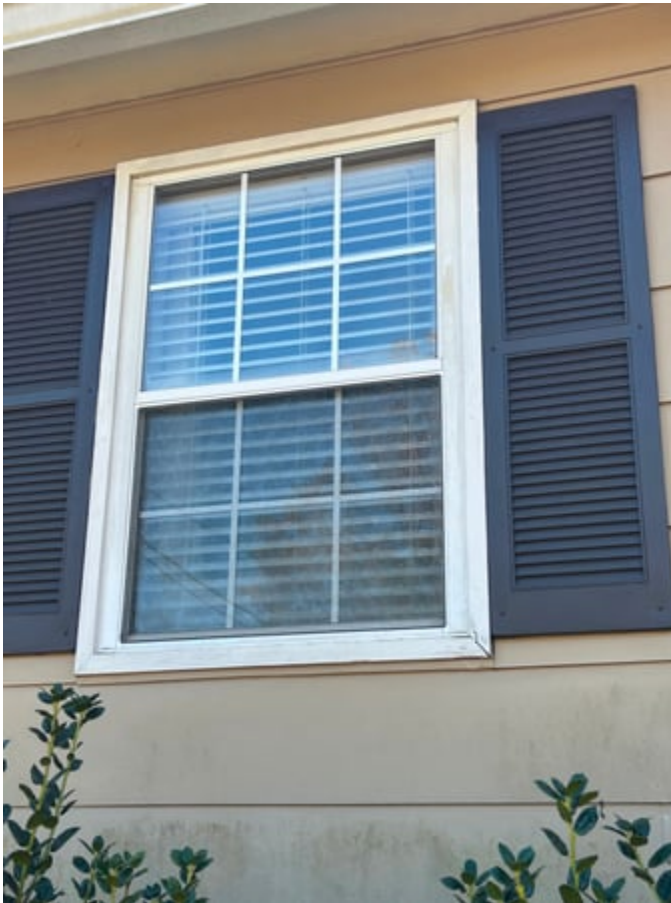
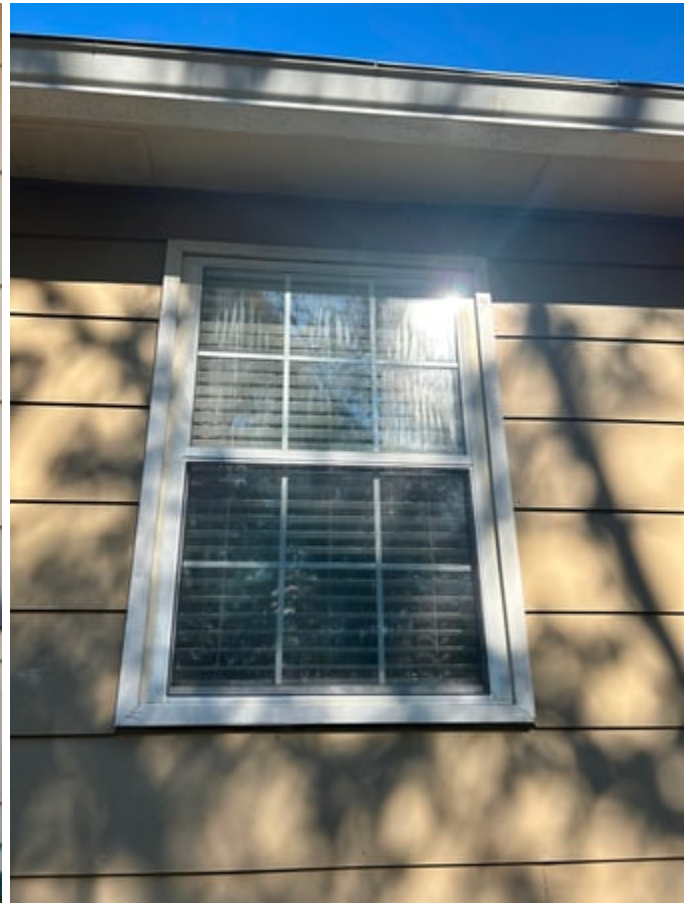
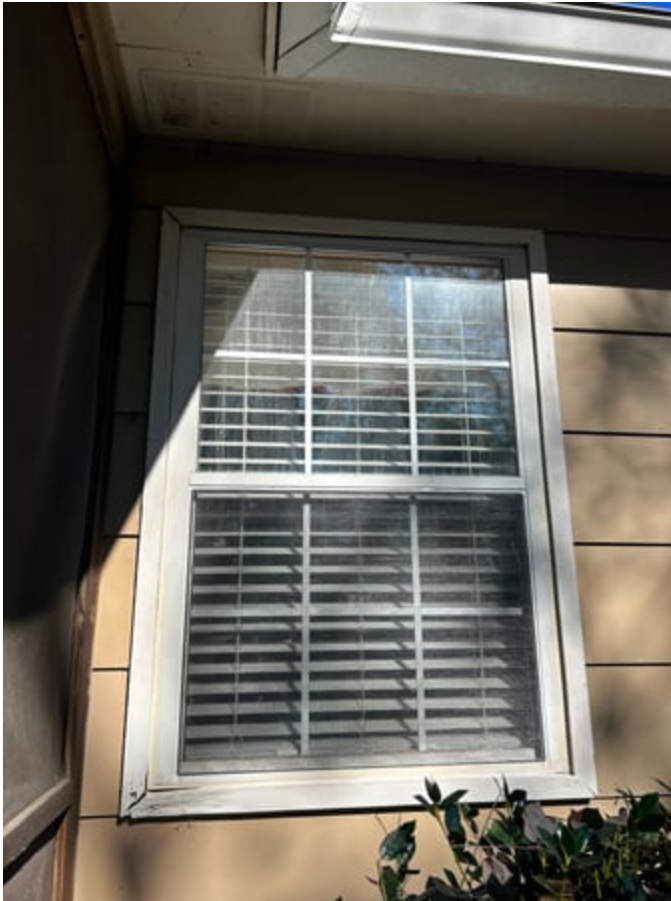
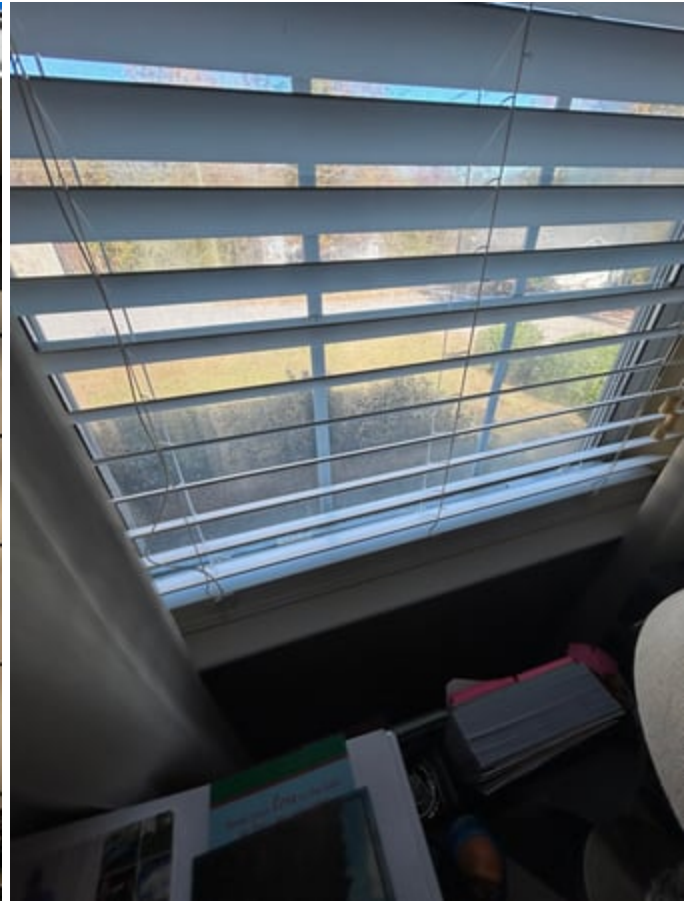
Windows (a representative number)

Trim on several windows showed water damage and wood rot. Windows showed condensation within.

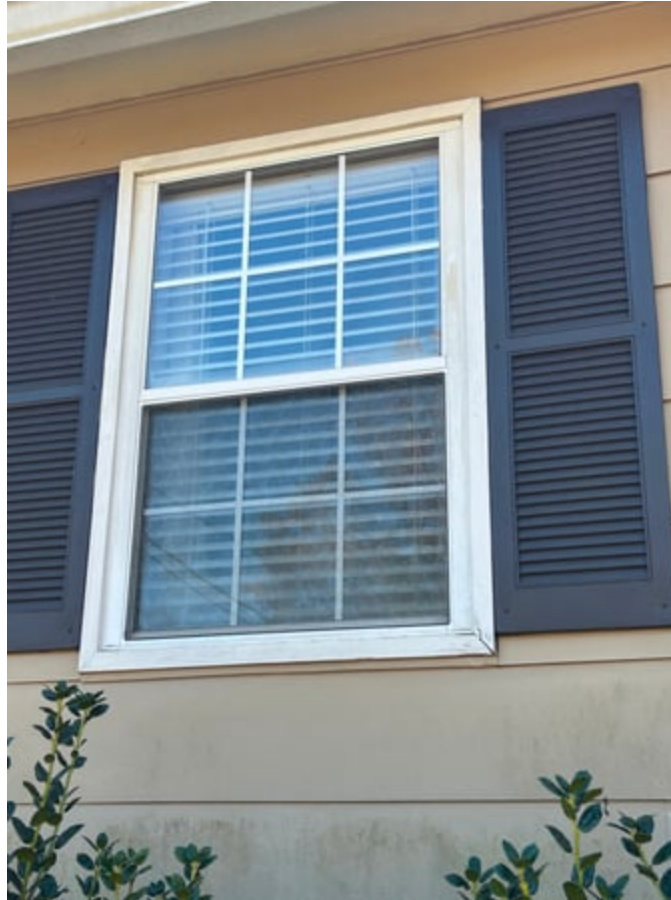
Flashing and Trim

Trims on several windows showed rot and recommended replacement.

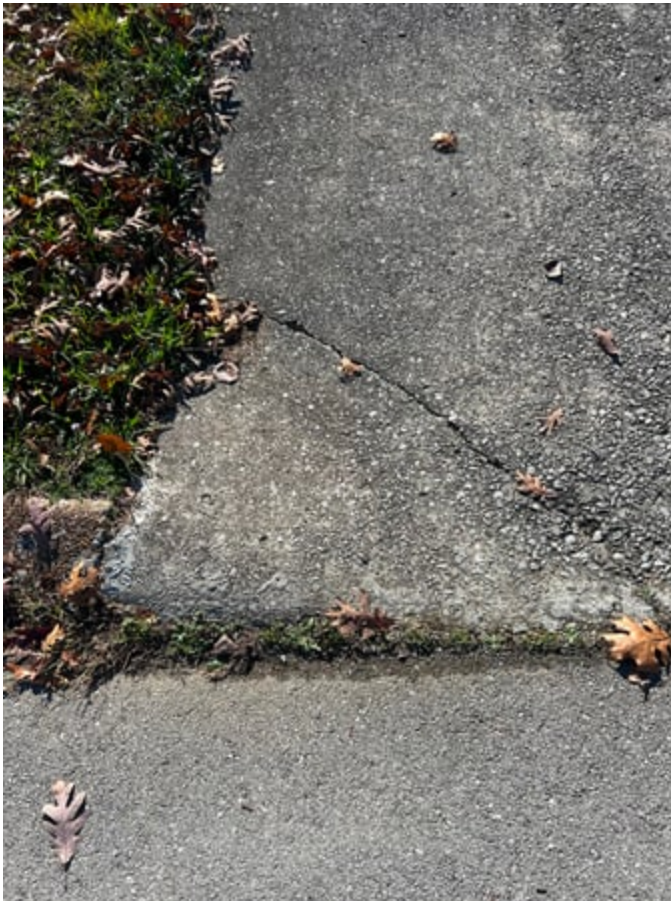
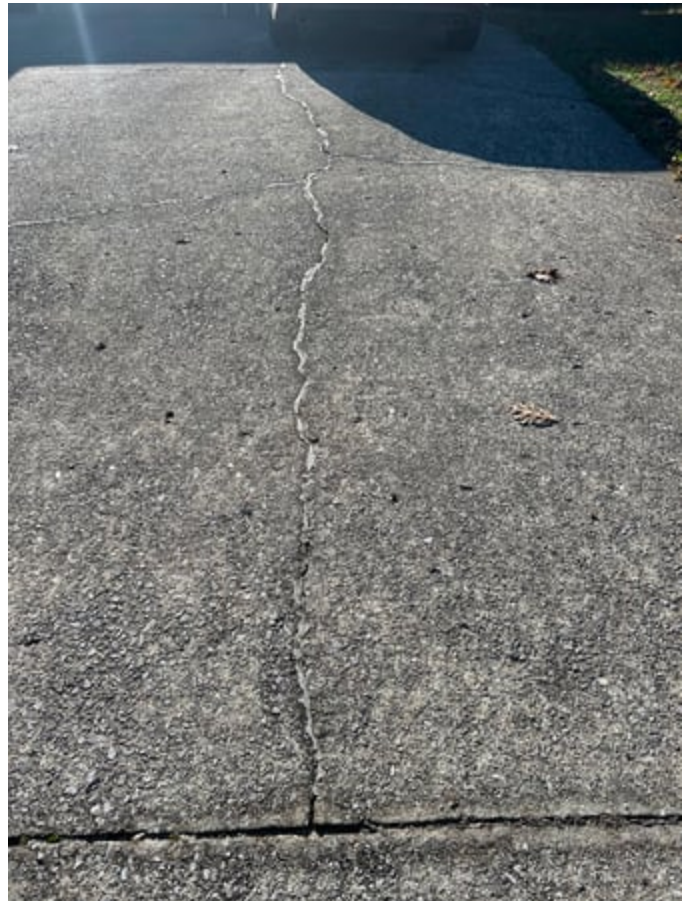
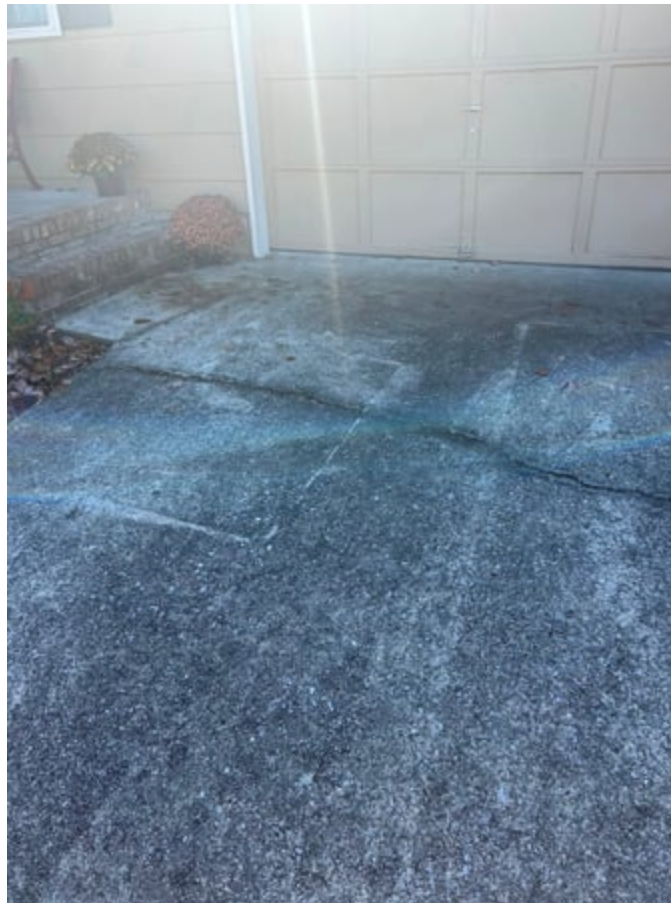
Adjacent Walkways and Driveways

Driveway showed cracks which had been filled but could use additional repairs.

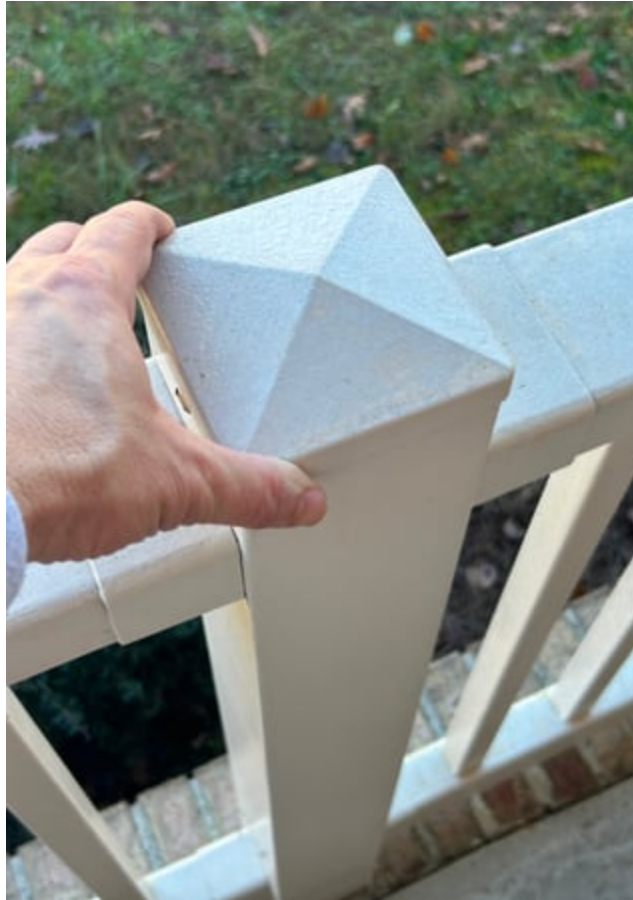
Railings, Guards and Handrails

Front porch guard was found to be and recommend repair.

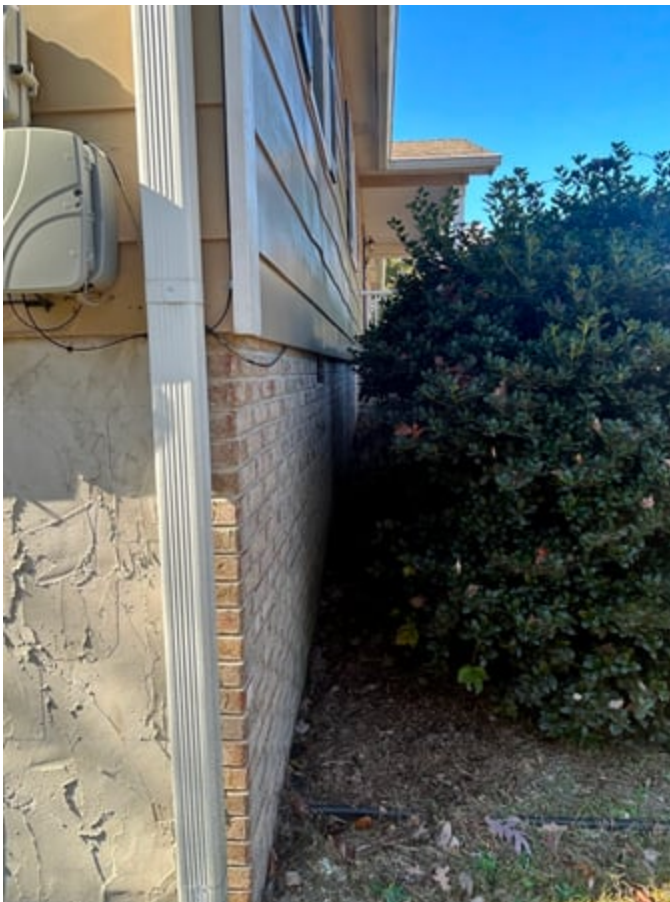
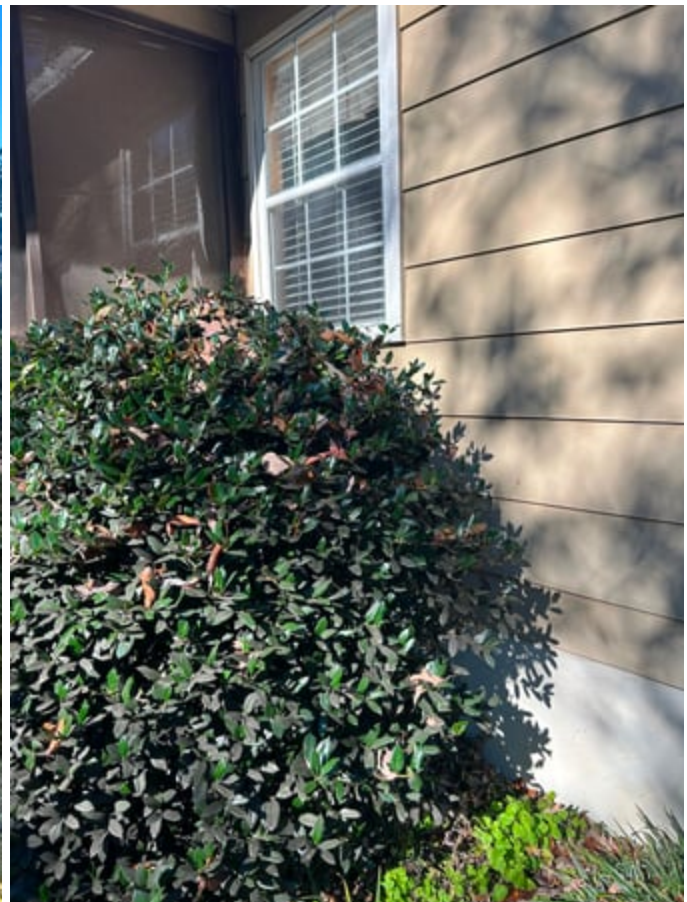
Vegetation, Surface Drainage, Retaining Walls and Grading of the Property (where they may adversely affect the structure due to moisture intrusion)

Vegetation found to be too close to home in areas in front and rear.
Recommend that vegetation be cut back away from home.

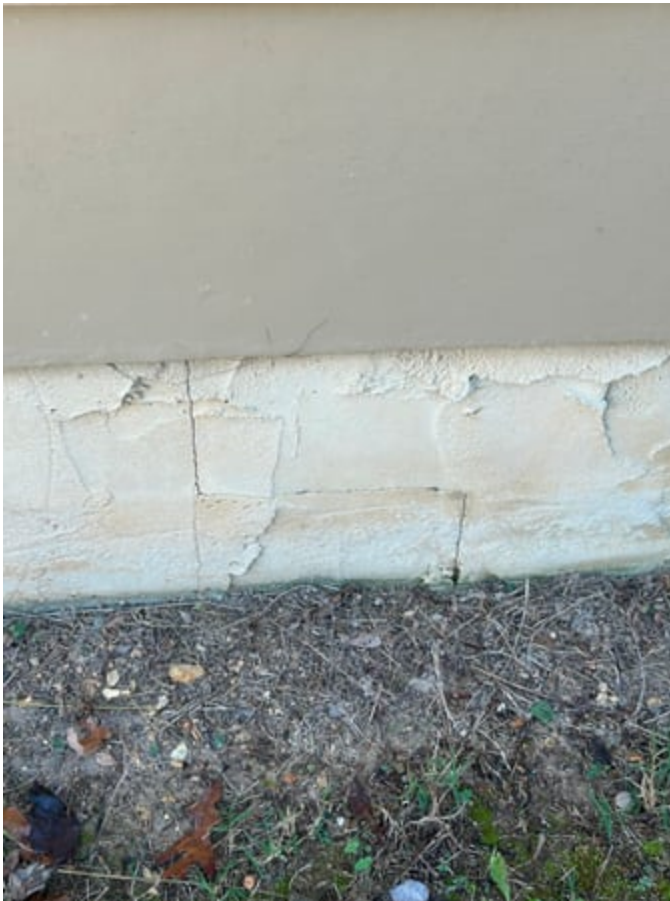
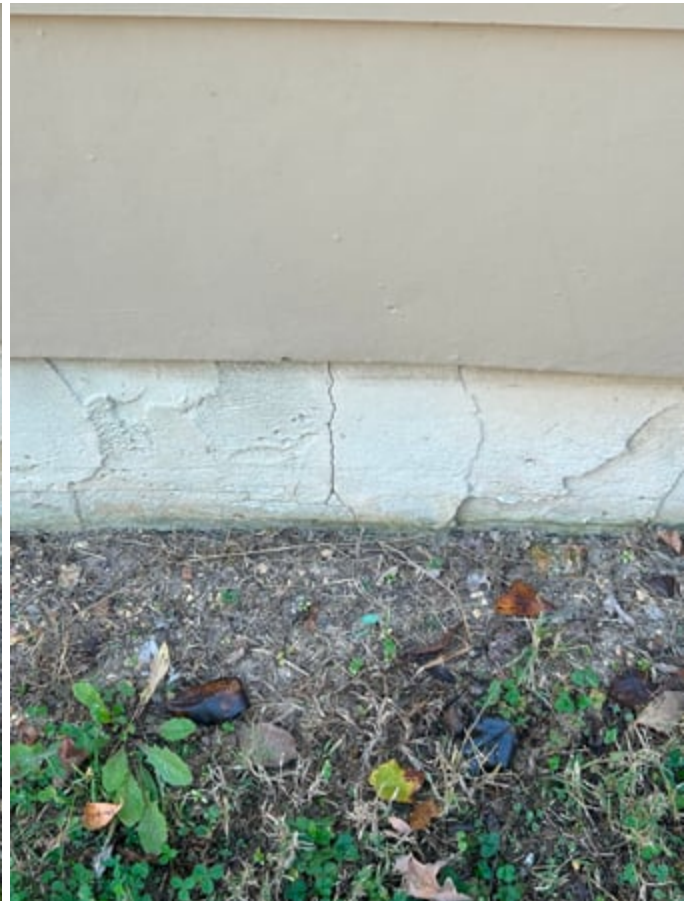
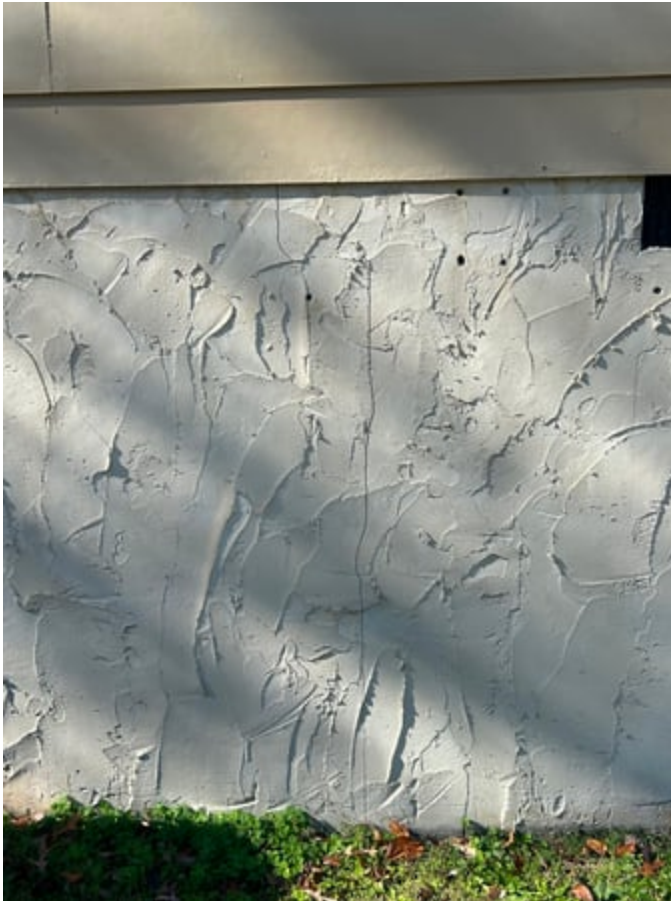
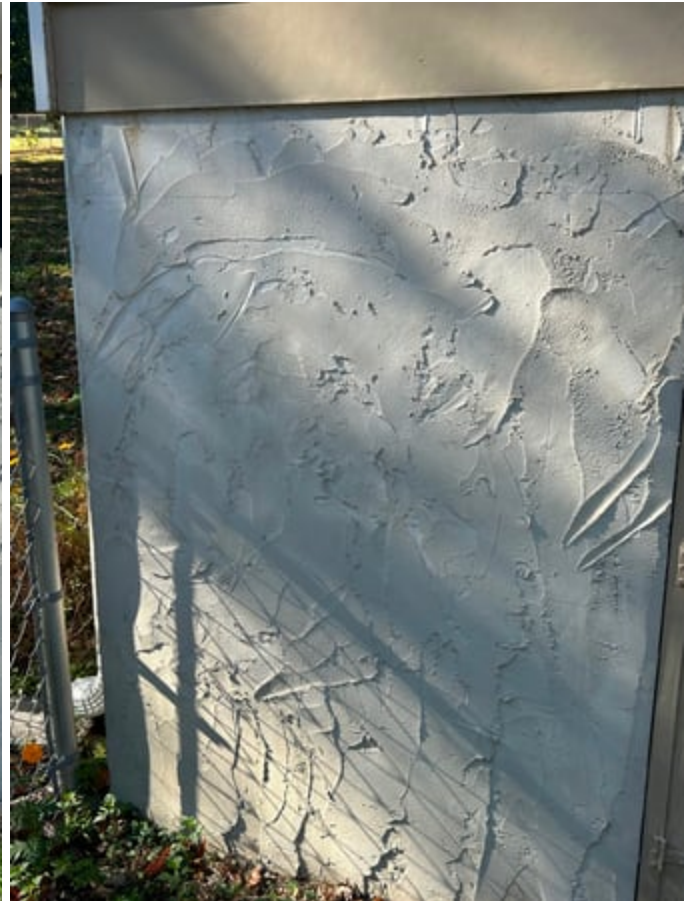
Foundation

Settlement cracks noted in several areas of foundation in stucco material.
