Mock Inspection Report

67 Squirrel Circle, Ringgold, GA, USA

Nov 16, 2024

This is a mock inspection report to demonstrate that the inspector has performed an inspection according to the [InterNACHI® Standards of Practice](#).

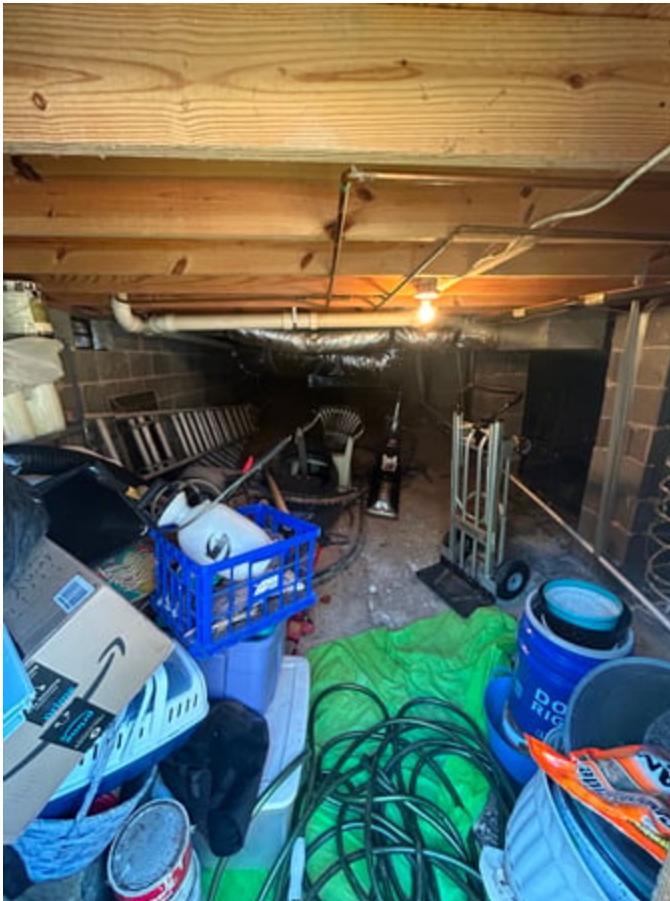
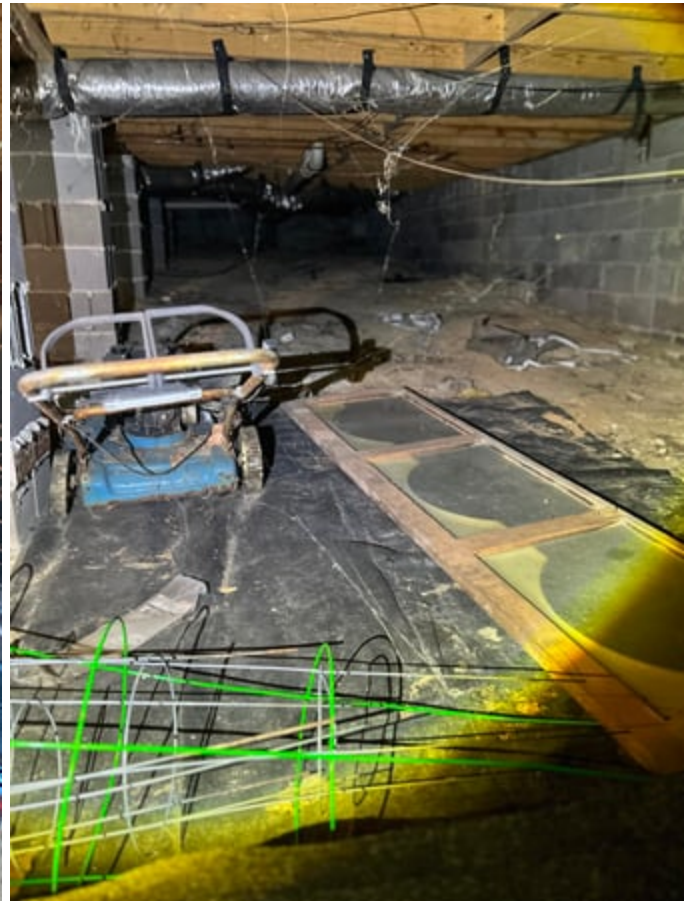
Crawlspace

No vapor retarder present at time of inspection. Some areas not visible do to occupants possessions.

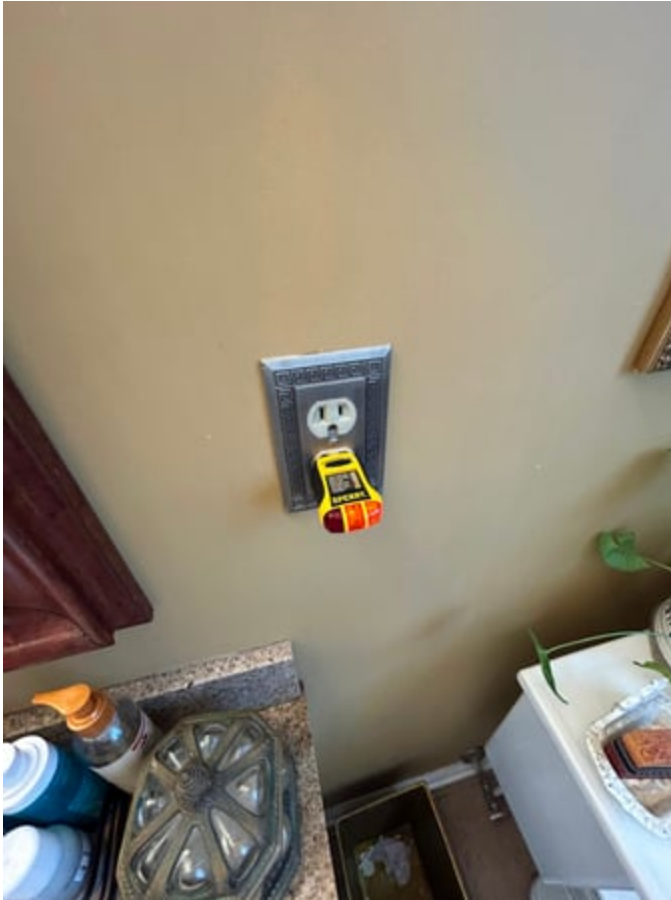
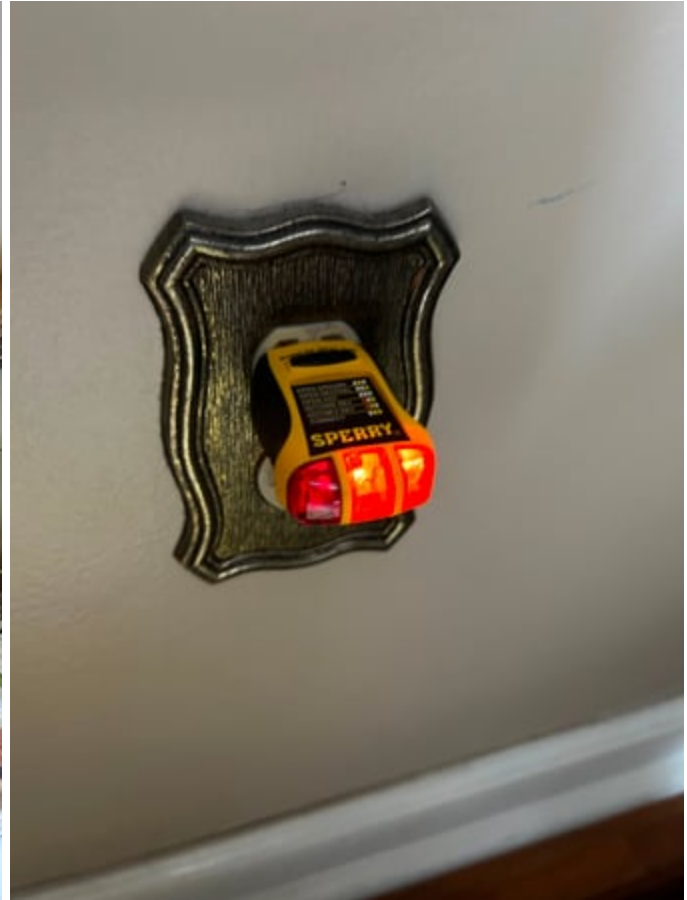
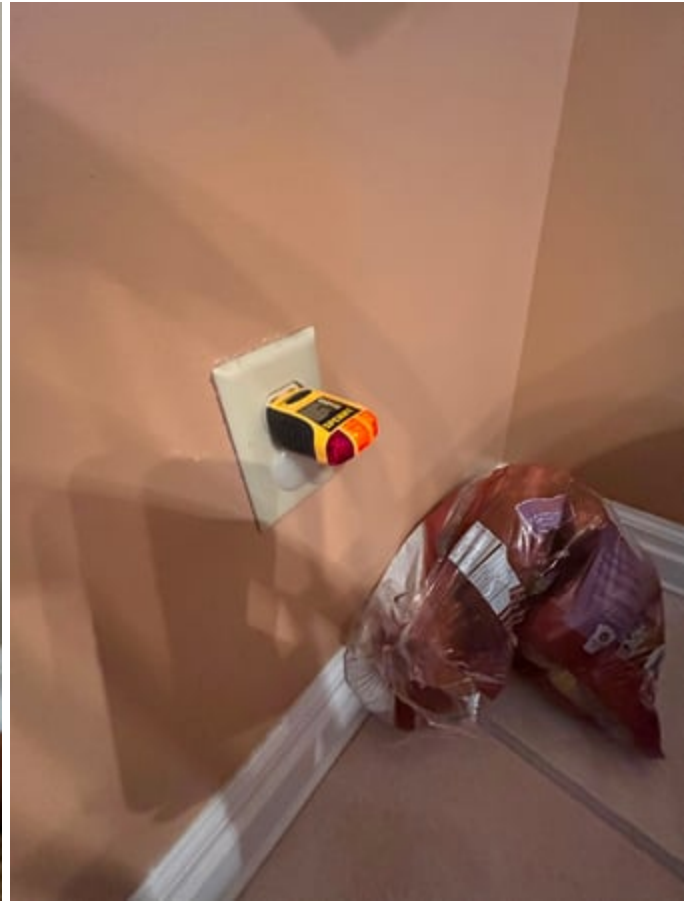
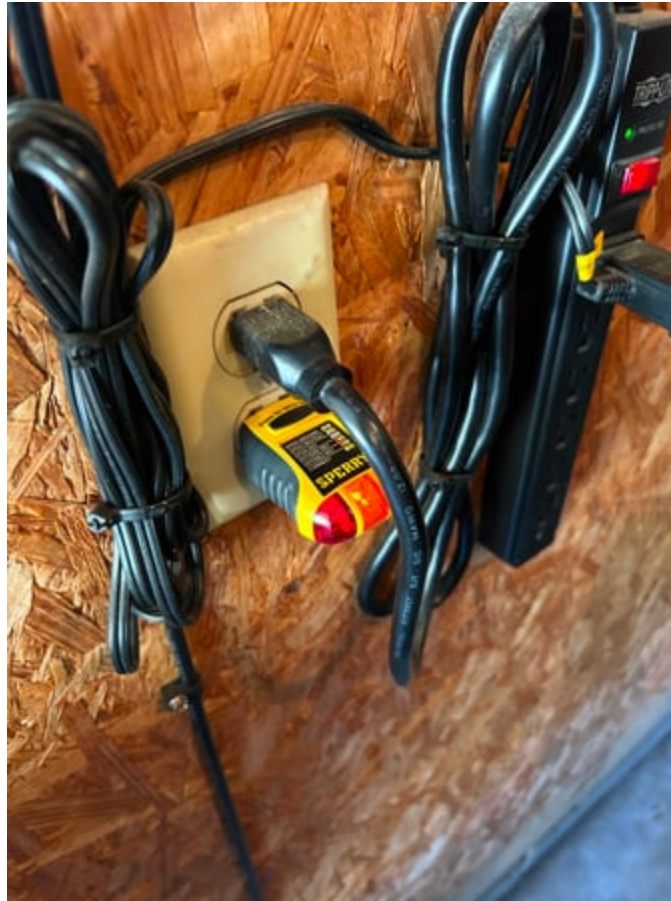
Switches, Lighting Fixtures and Receptacles

None present in home.

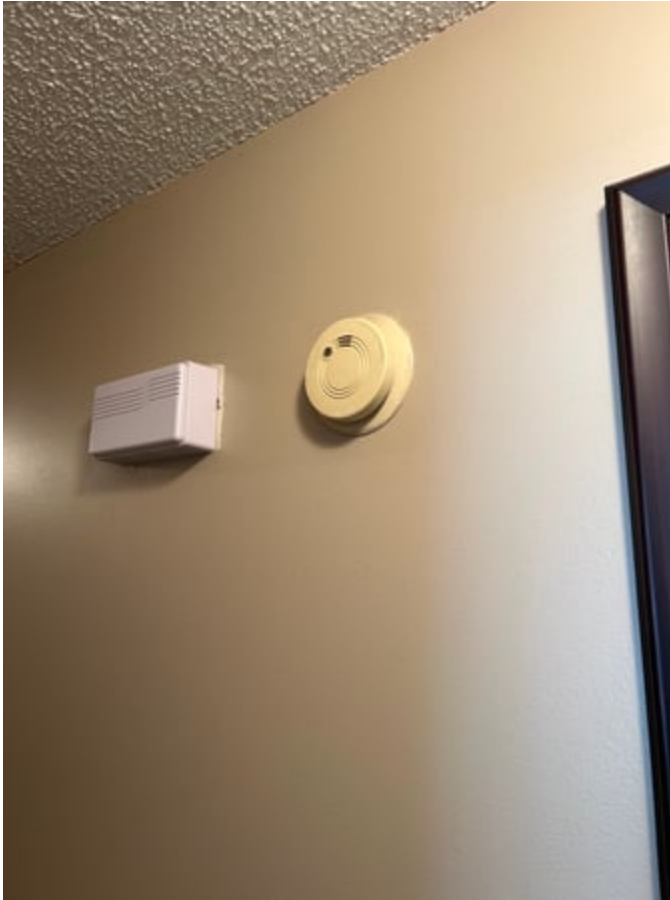
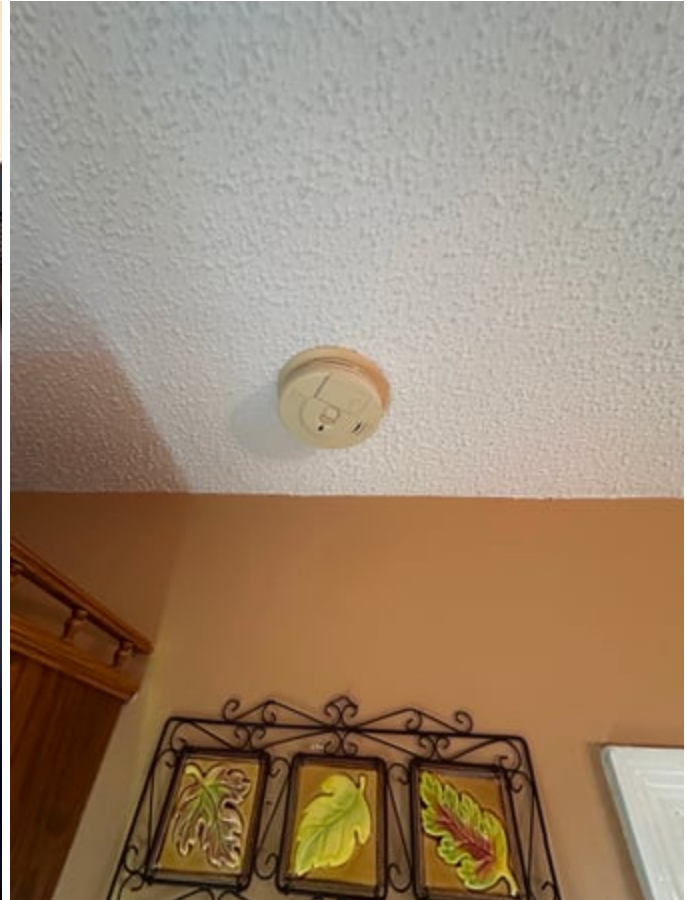
Presence of Smoke and Carbon-Monoxide Detectors

Smoke detectors out of date and no carbon monoxide detectors in home.

No carbon monoxide detectors and smoke detectors were old.

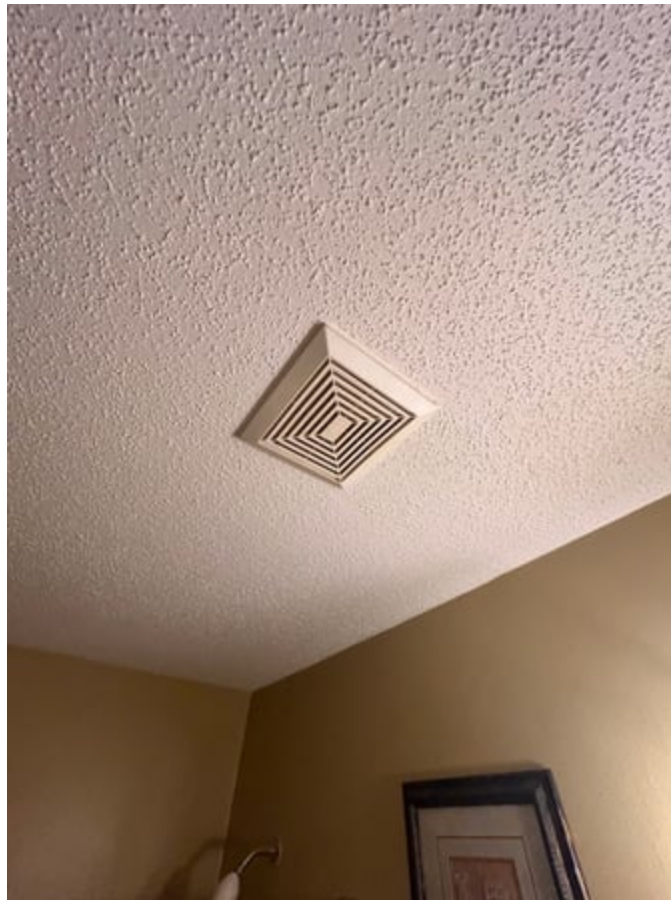
Bathroom exhausted into attic and not exterior

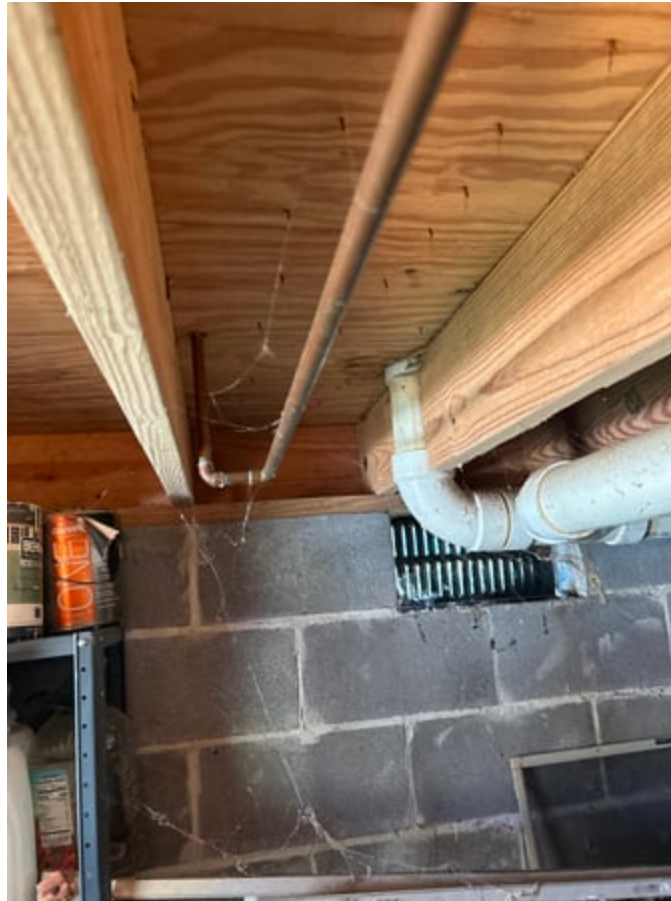
The Type of Insulation Observed

- None present in crawl space.

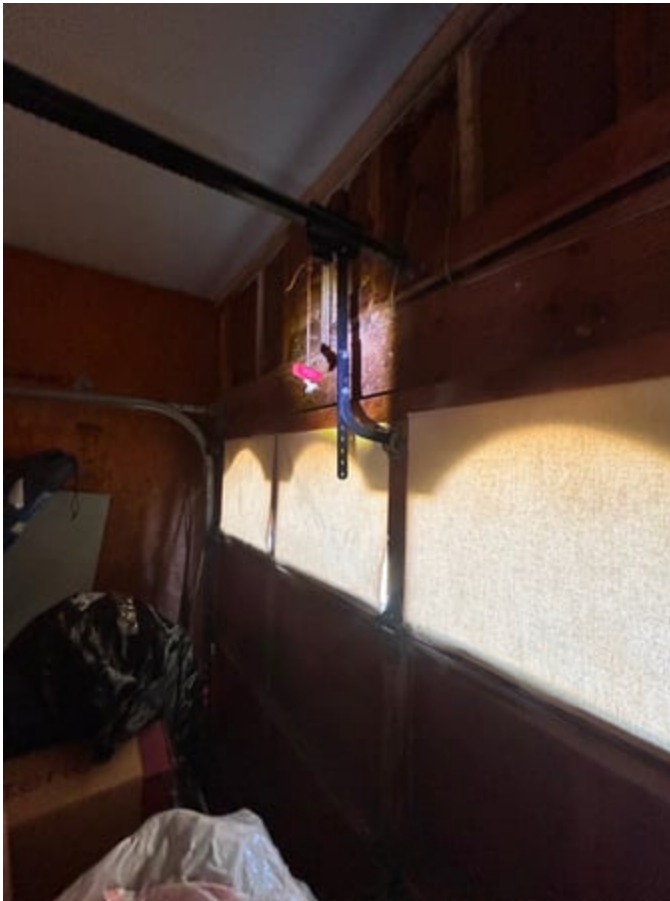
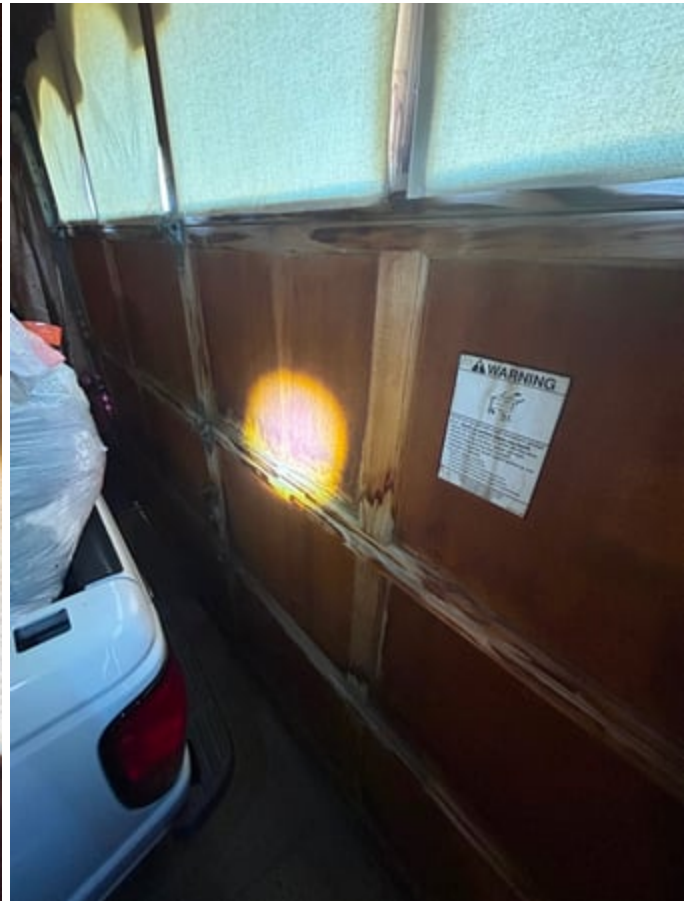
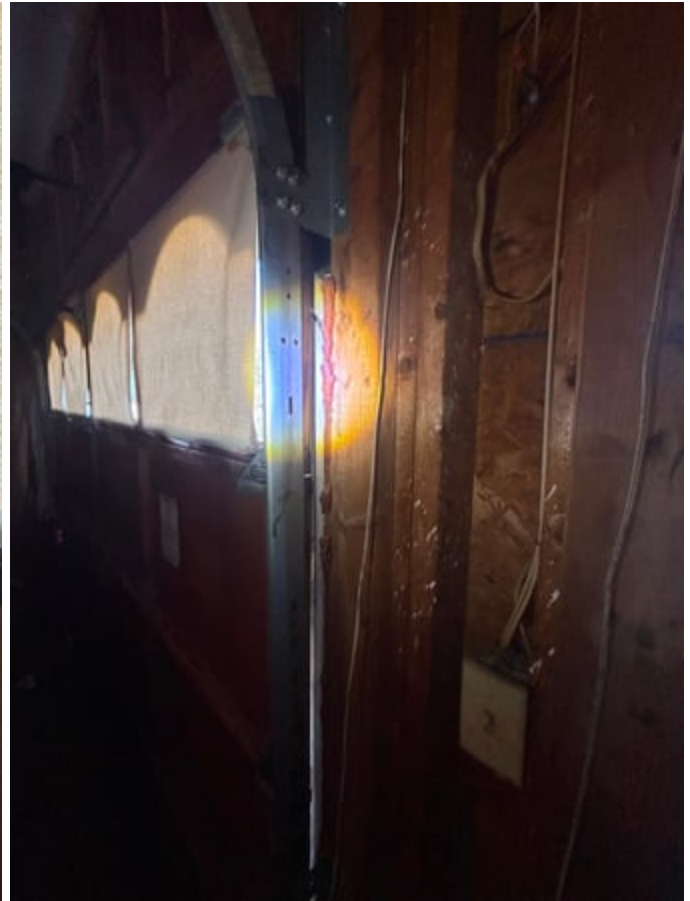
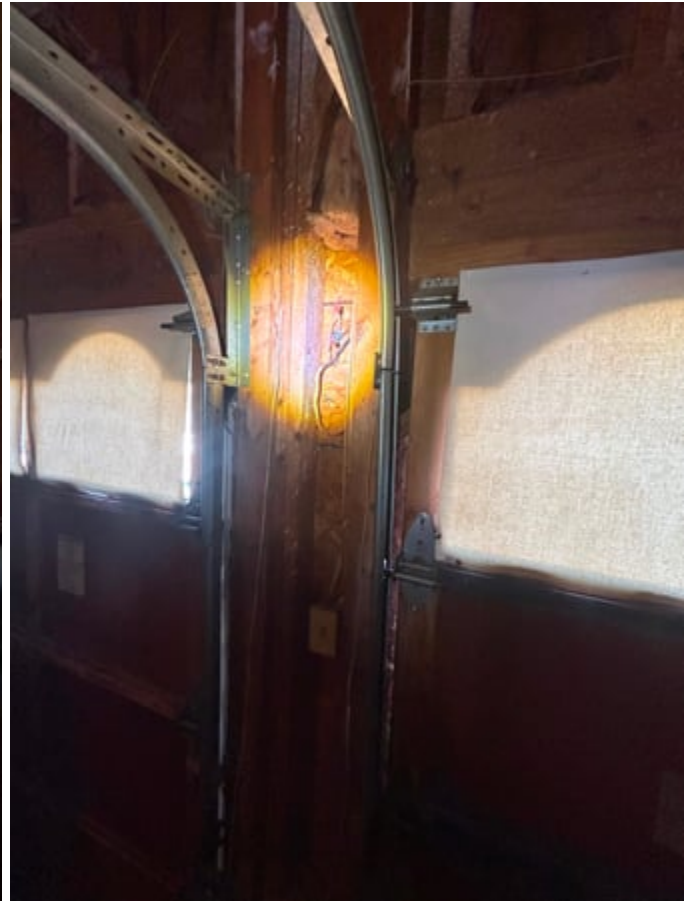
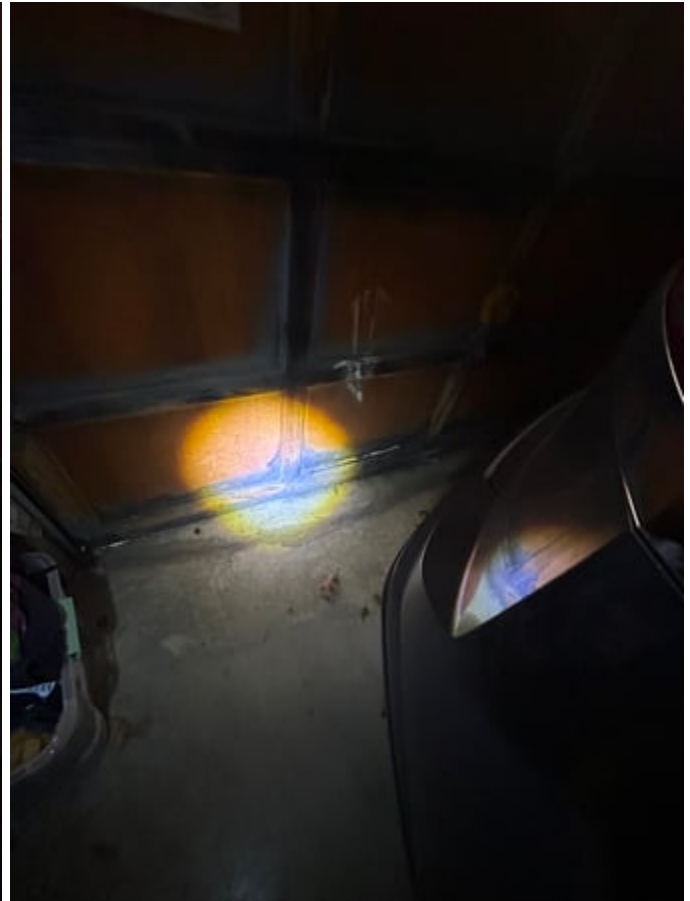
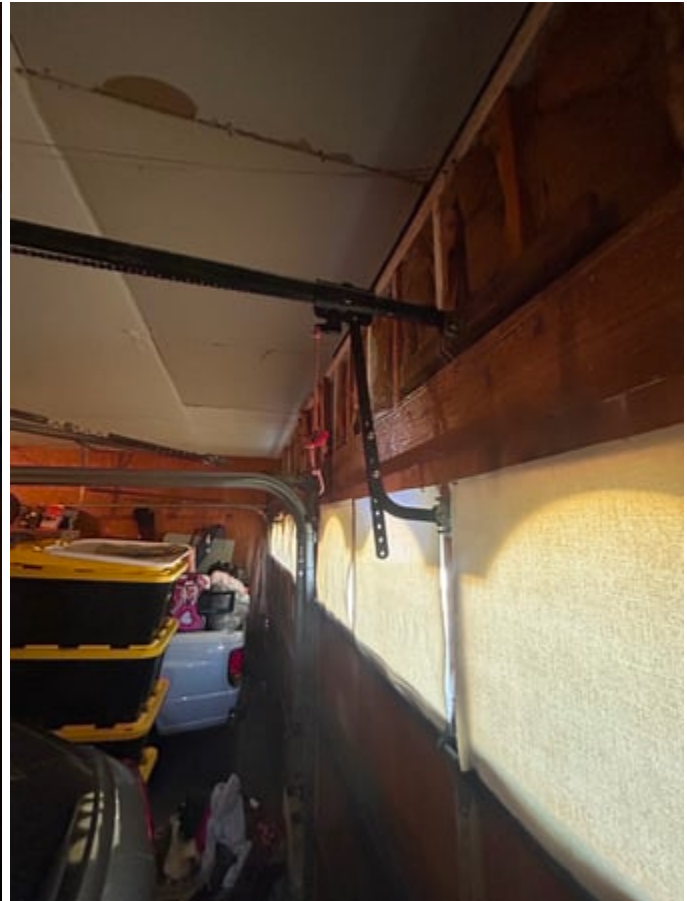
Eye beams were located too high. Door panels showed water damage. Springs did not have cables.
