## Home Inspection Report

149 Kailors Cove Circle  
Ringgold, GA 30736

**Inspected By:** Michael Teems

**Prepared For:** Emilee Teems  
Inspected on Sat, Jul 26, 2025 at 8:45 AM

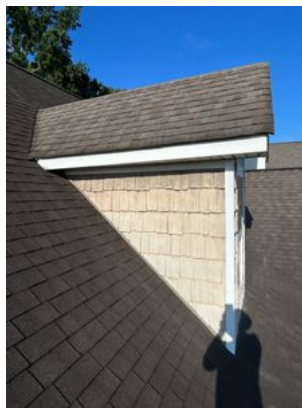
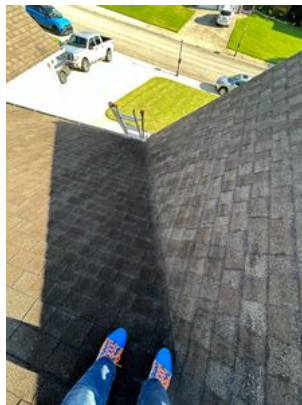
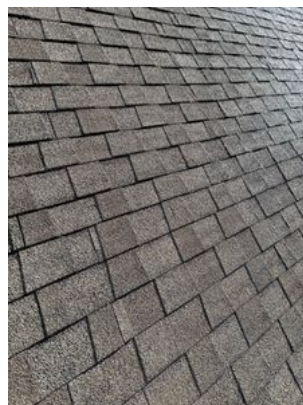
Roof is near end of service life. Noticed granular loss, cupping, frayed edges, hail damage, and brittle shingles. Typical life expectancy of asphalt roof shingles is 20 to 30 years, but this varies based upon several factors such as rain, heat, hail, wind, etc.

Recommend monitoring for active rain leaks and for roof to be replaced by licensed roof contractor when needed.

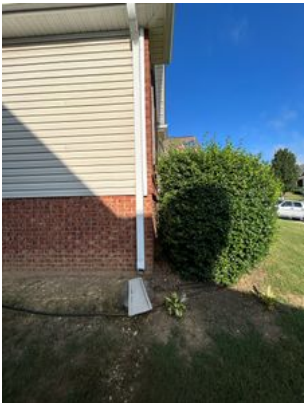
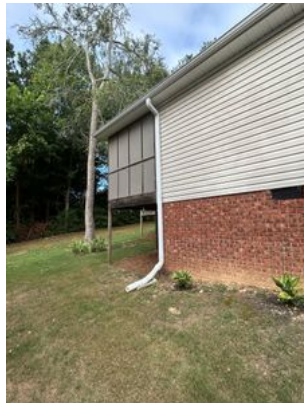
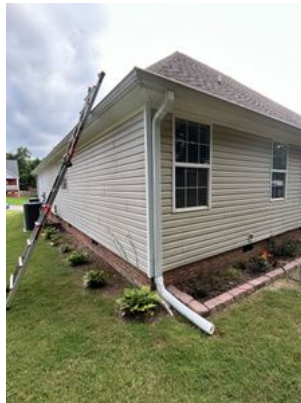
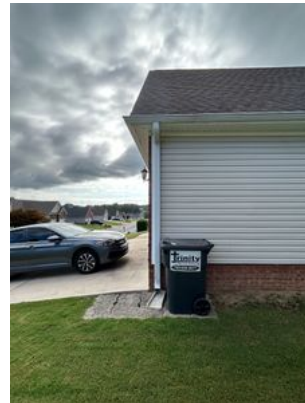
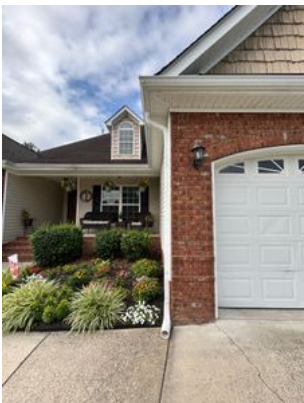
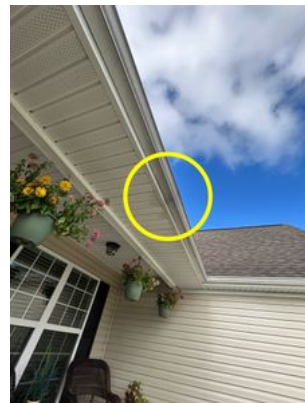
Downspouts were observed to be in position to divert water away from home and foundation. Downspout at walkway will divert water onto walkway and potential slip hazard in colder weather.

Gutters observed to have some debris in them at rear porch of house in area near tree. Regular maintenance will be needed to keep gutters clean in order for water to drain properly. Areas in front and rear gutters showed signs of overflow. This needs to be monitored due to potential for standing water which could flow back into fascia areas.

Recommend review by qualified gutter contractor.

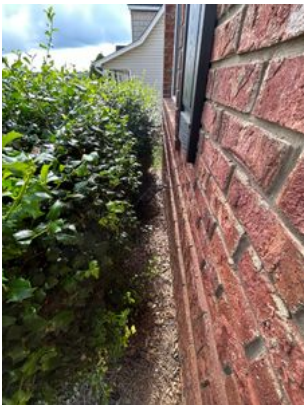
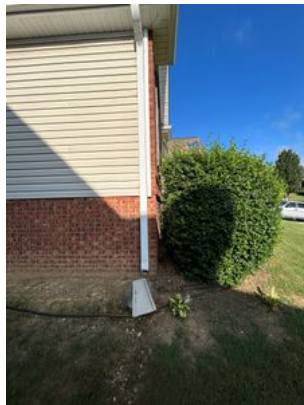
Tree in backyard found to be overhanging roof and should be trimmed to keep branches from falling on house and leaves from clogging gutter.

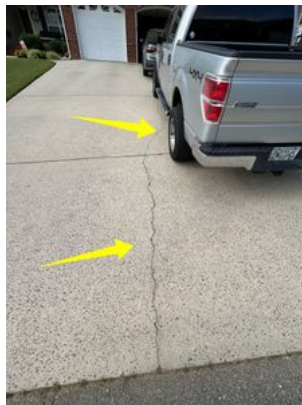
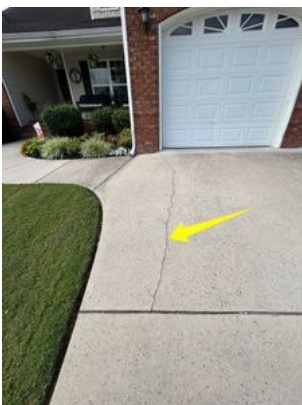
Several cracks were observed in the driveway. Cracks need to be repaired to prevent erosion of soil underneath. Cracks can create uneven surfaces which become trip hazards.

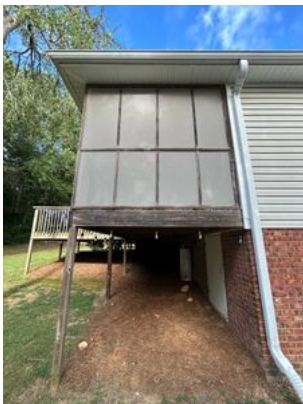
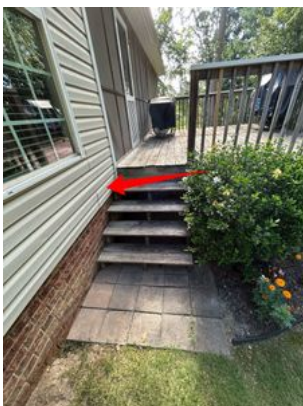
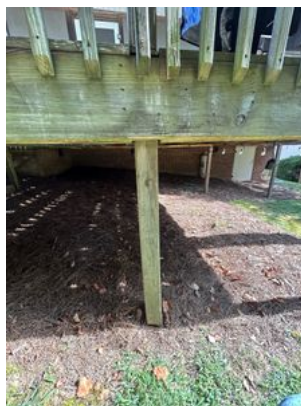
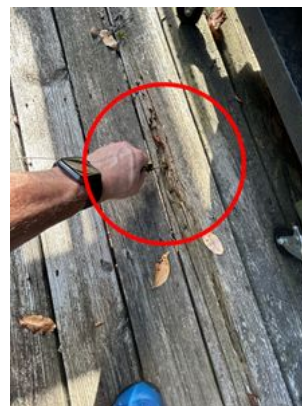
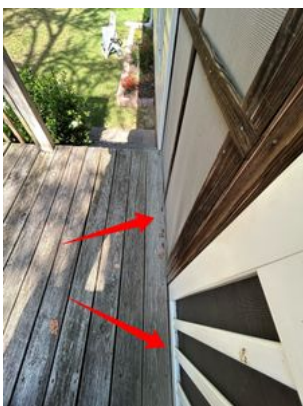
Deck needs to be reviewed by contractor. Several cracks were observed in wood beams and joists. Deck flooring and beam showed rotting wood and missing material. No deck flashing observed at ledger board and rear porch area. Several balusters were found to be loose and unattached.

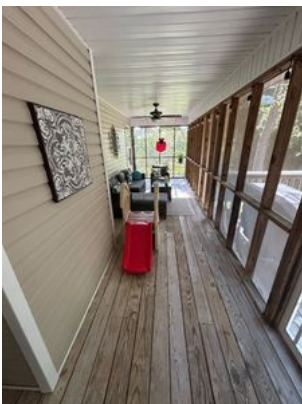
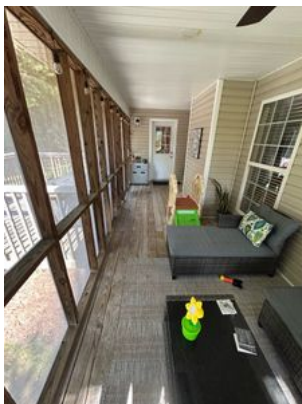
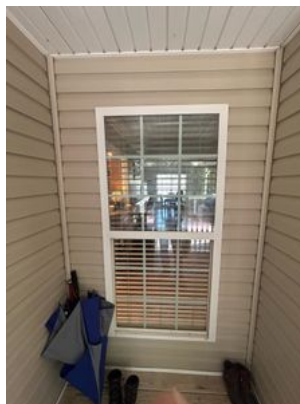
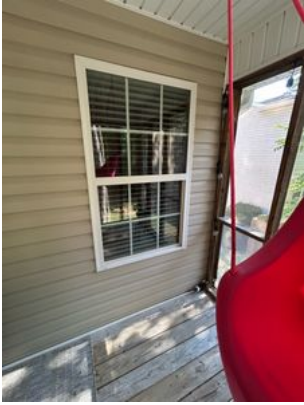
No balusters were observed but only screening. This is safety concern and needs to be evaluated and repaired by certified or licensed contractor to prevent someone from falling through screen.

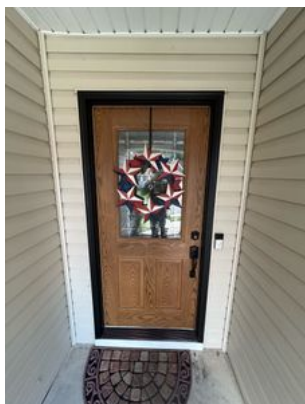
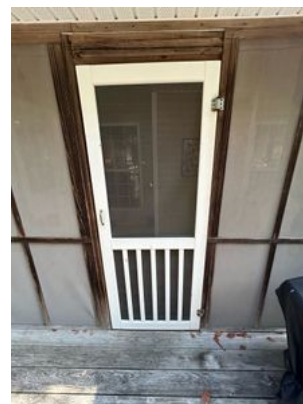
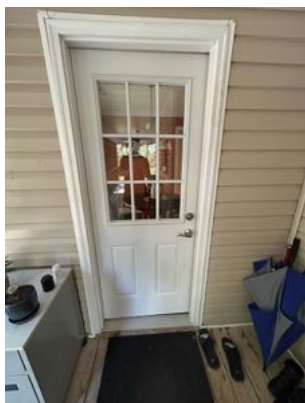
Front door seal found to be worn and in need of replacement. Recommend new seal be installed by qualified handyman in order to prevent air entering and leaving home.

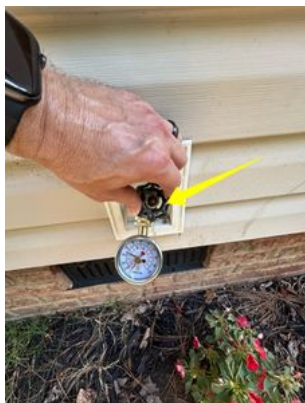
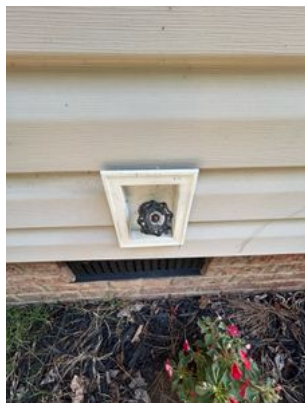
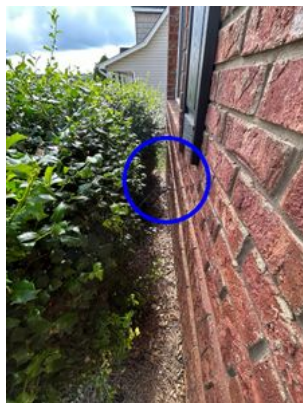
**Comment 17**

Rear spigot was found to be loose. Water pressure found to be 50 psi. Acceptable levels are between 40 and 80 psi. Recommend repair by qualified handyman .

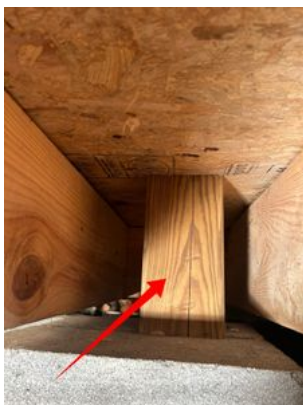
#### **Comment 22**

Pier located below kitchen nook area found to have support on top of pier making direct contact with floor sheathing. Recommend further evaluation from structural engineer.

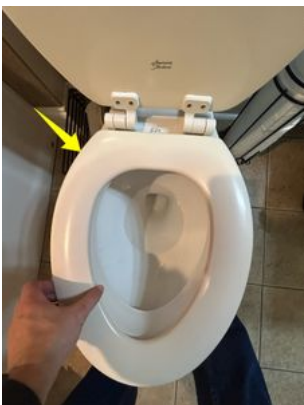
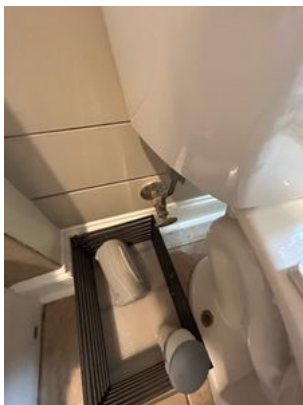
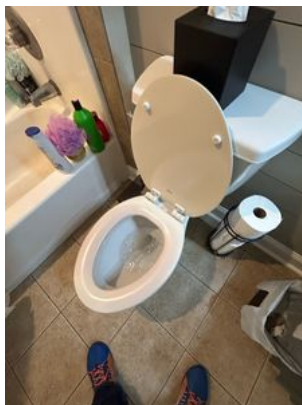
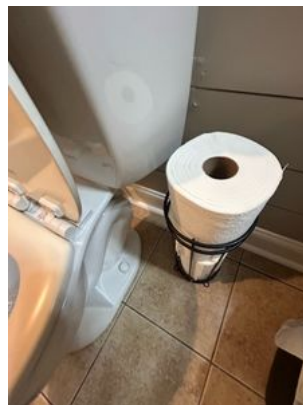
### **Comment 26** **Information**

Toilet seat observed to be loose. Recommend repair by qualified handyman.

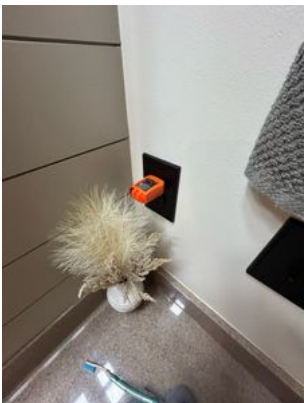
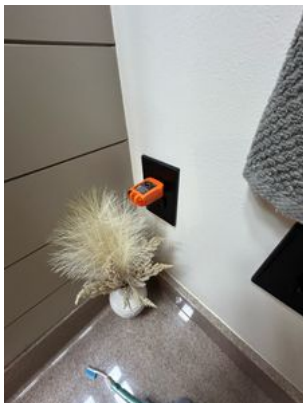
### Comment 28 Information

GFCI resets at breaker in the garage panel board.

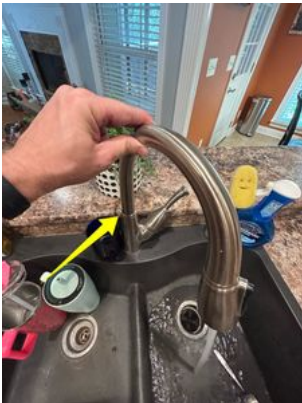
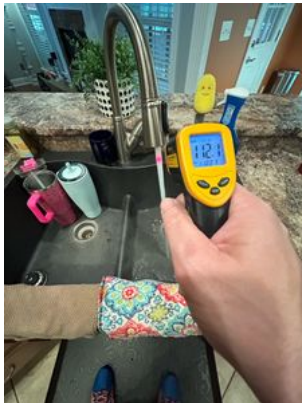
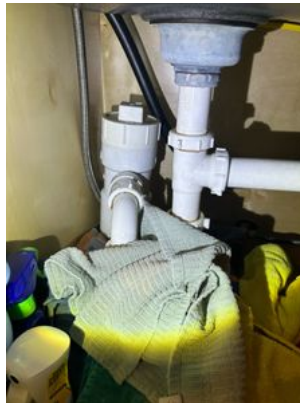
### Comment 29

Sink nozzle found to be loose and should be tightened by qualified handyman.

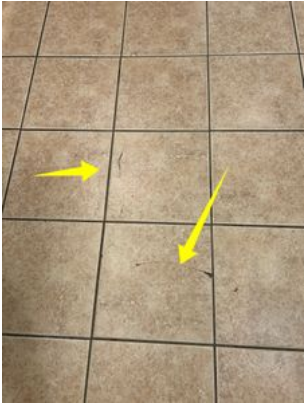
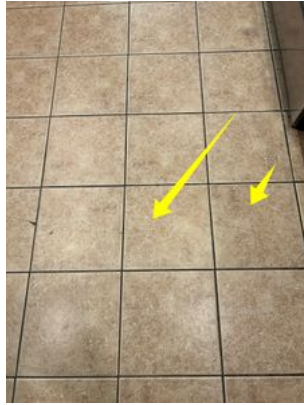
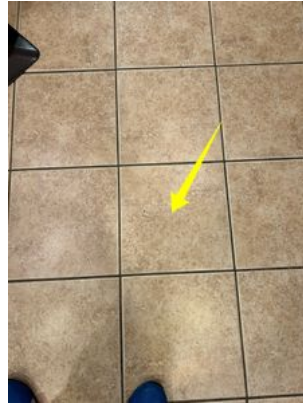
### Comment 31

Noticeable cracks observed in various areas of kitchen floor. Floor shows not to be level in kitchen nook area. Further evaluation recommended from Structural Engineer.

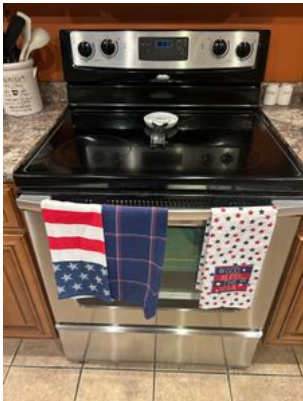
#### Comment 32

Range was not mounted to wall with anti tip safety bracket. Recommend installation of bracket by qualified handyman.

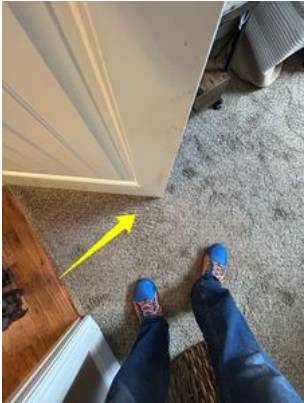
#### Comment 34 Information

Door was found to drag upon surface of carpet when opening and closing. Recommend adjustment of door by qualified handyman or contractor.

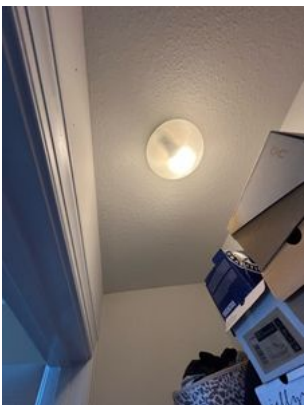
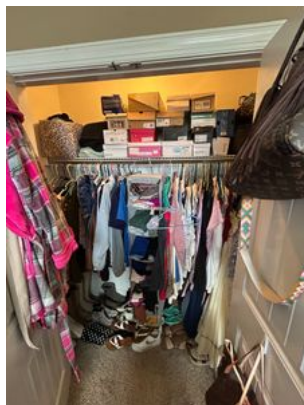
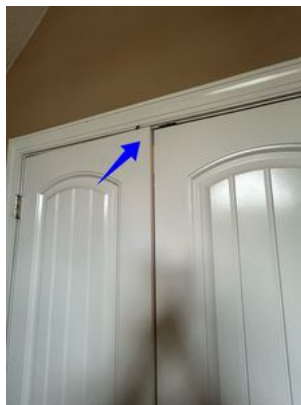
#### Comment 35 Information

Closet door didn't close properly. Recommend repair by qualified handyman.

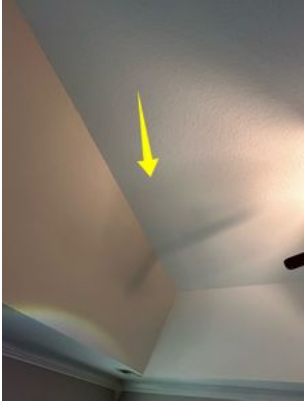
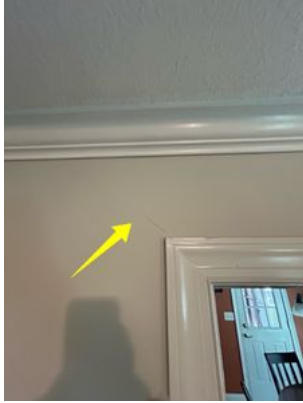
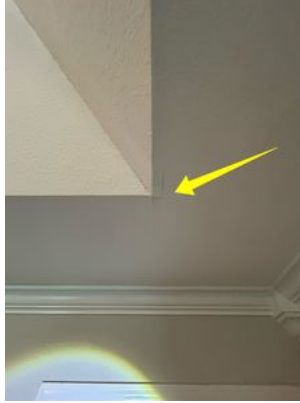
Condition: Further Evaluation Required

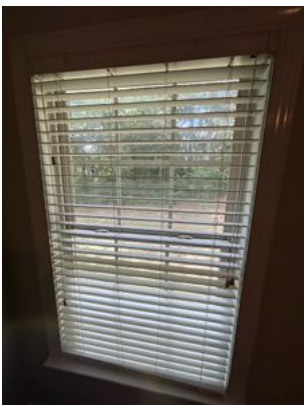
Condition: Marginal

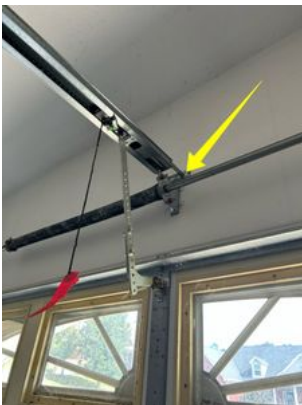
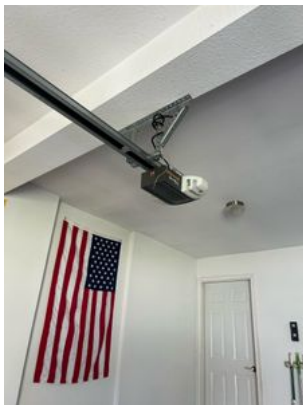
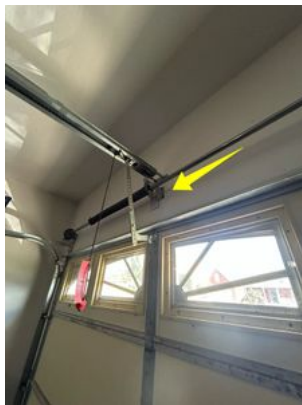
### Comment 42

Condition: Marginal

Both garage door tracks were mounted to the drywall. Recommend best practice is not mount to drywall, but rather to solid ledger board.

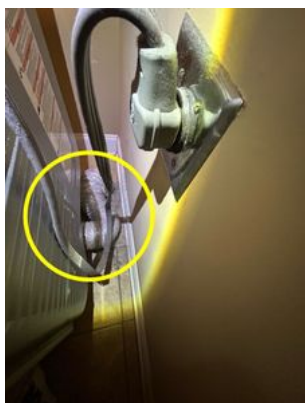
#### Comment 48

Dryer duct area seemed to be tight but flex duct seemed excessive. Recommend review by licensed contractor to reduce ductwork and possible restricted flow. Excessive lint observed behind dryer, recommend cleaning and verify duct is secured to dryer.
