Mock Inspection Report

67 Squirrel Circle, Ringgold, GA, USA

Nov 16, 2024

This is a mock inspection report to demonstrate that the inspector has performed an inspection according to the [InterNACHI® Standards of Practice](#).

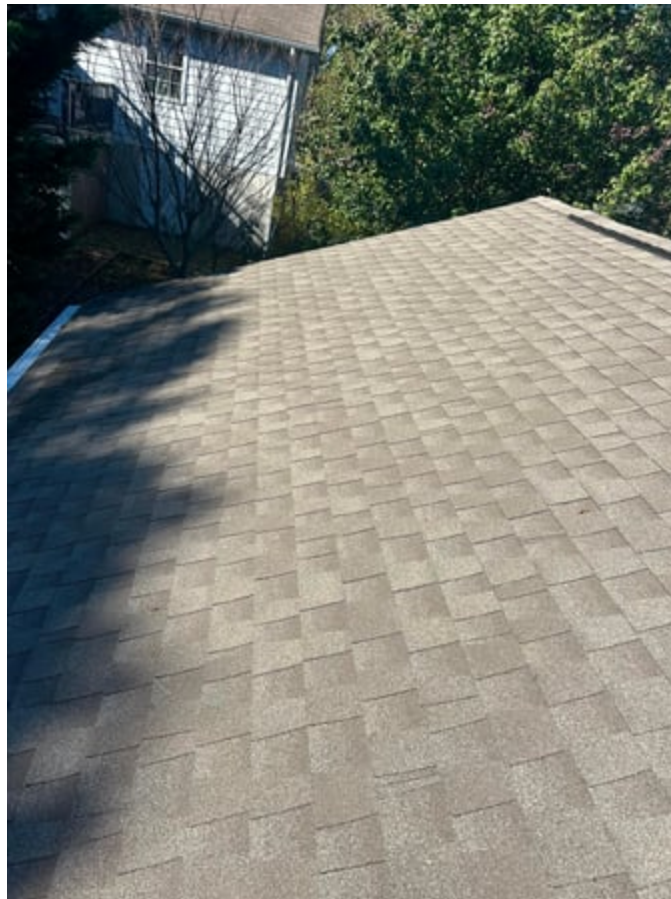
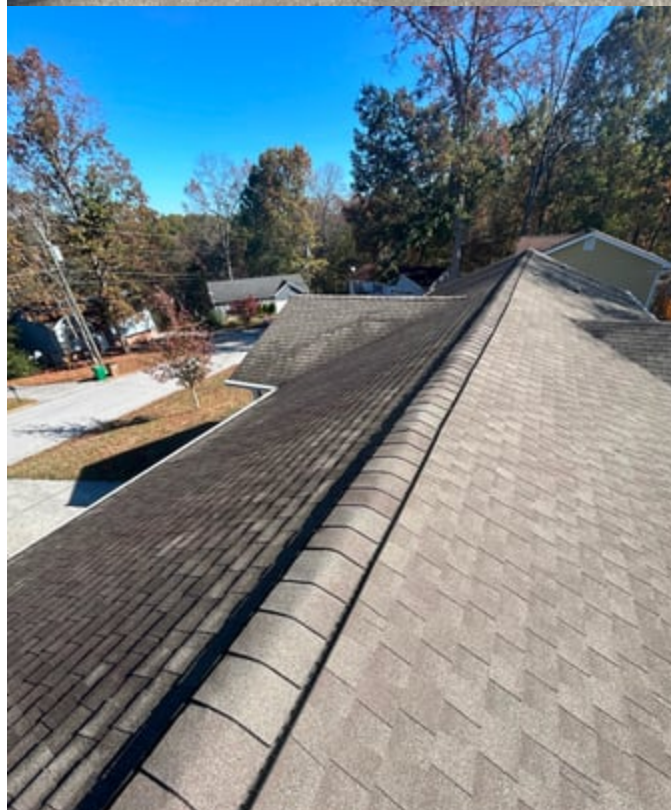
- Asphalt Shingle
- Roof shingles were found to be in very good shape.

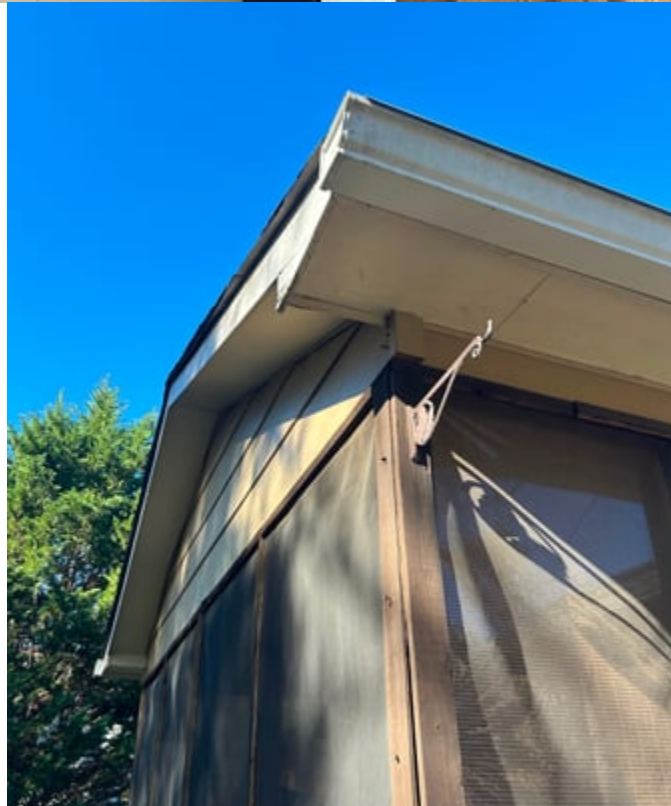
There were several areas noted with missing material and damage.

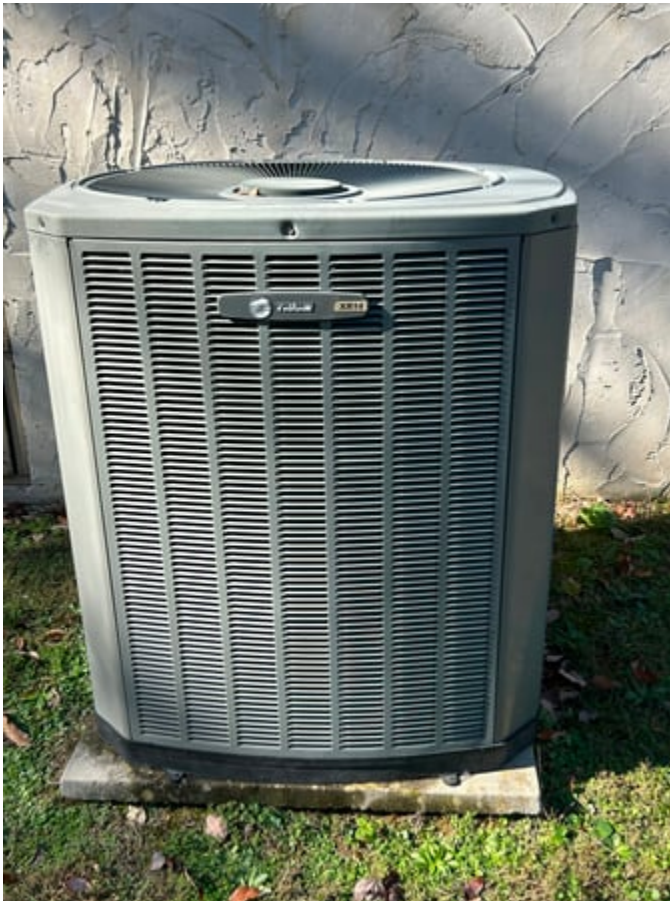
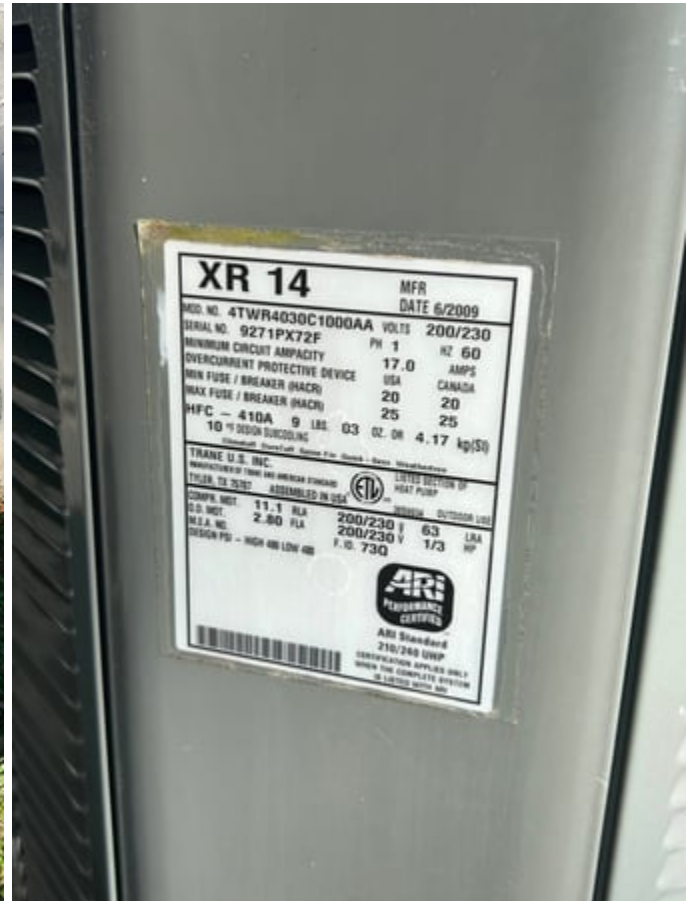
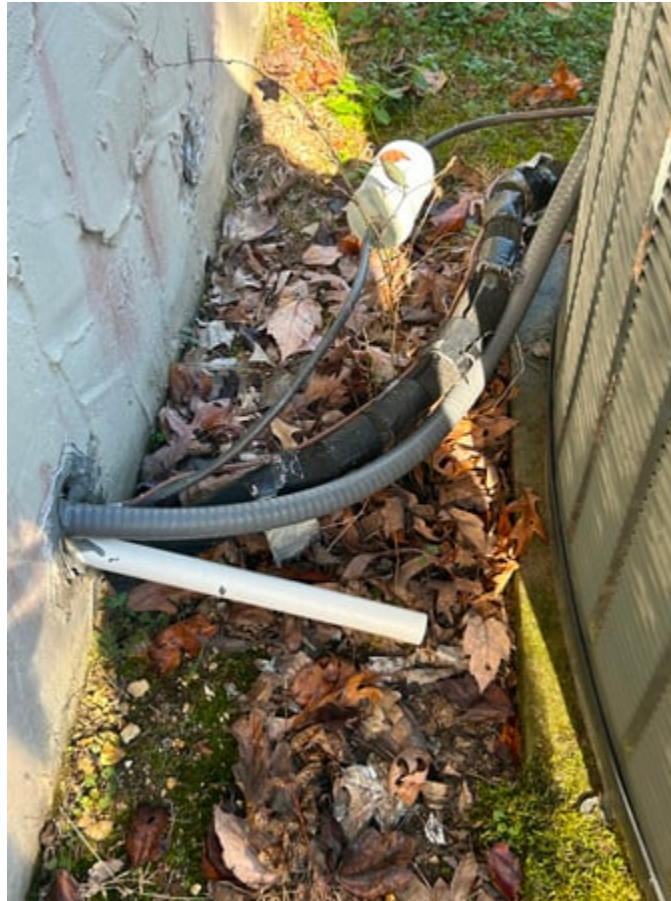
Heating System (using normal operating controls)

No Defect(s) Observed

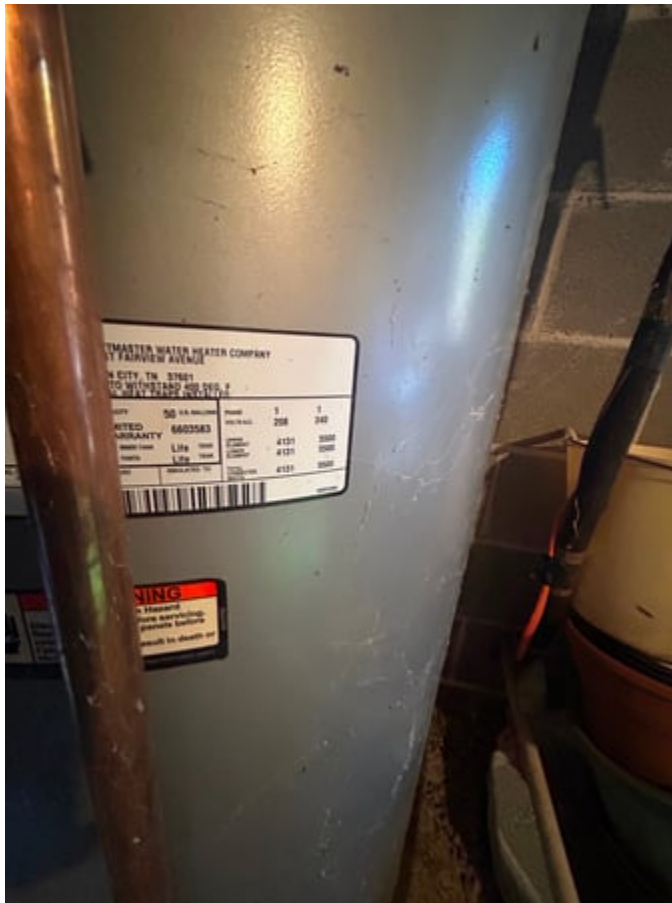
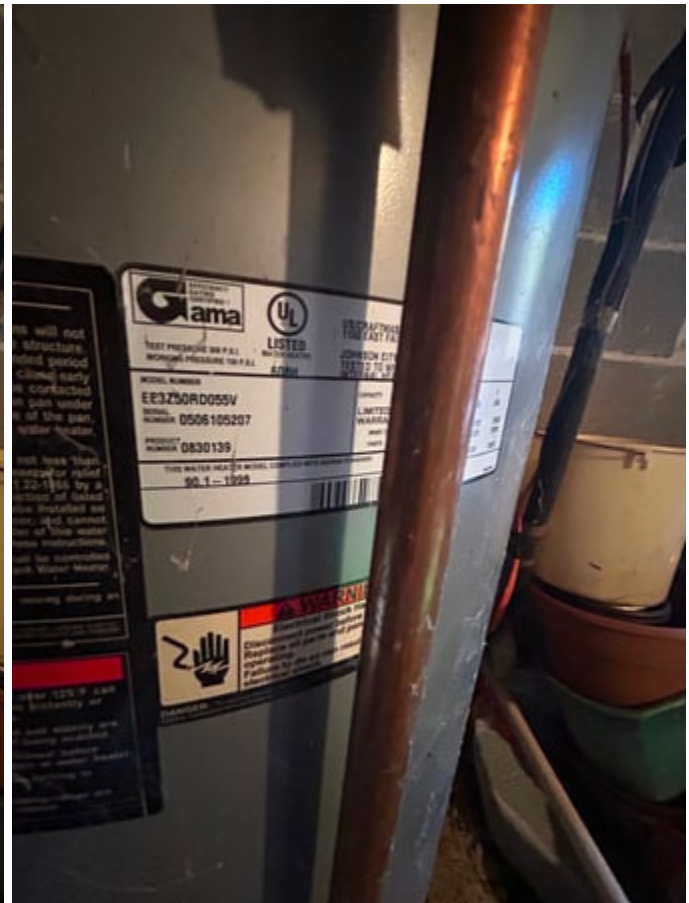
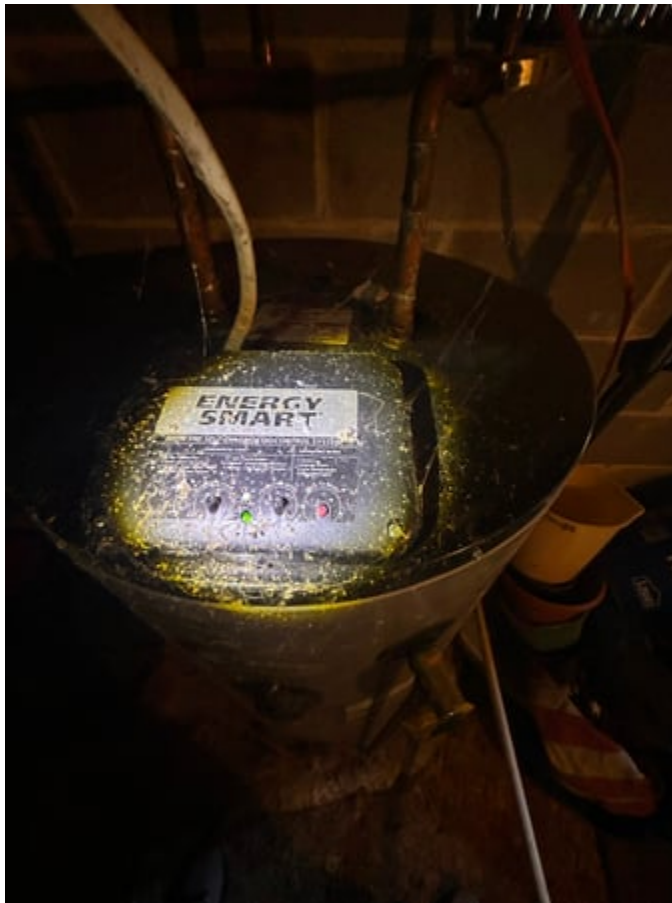
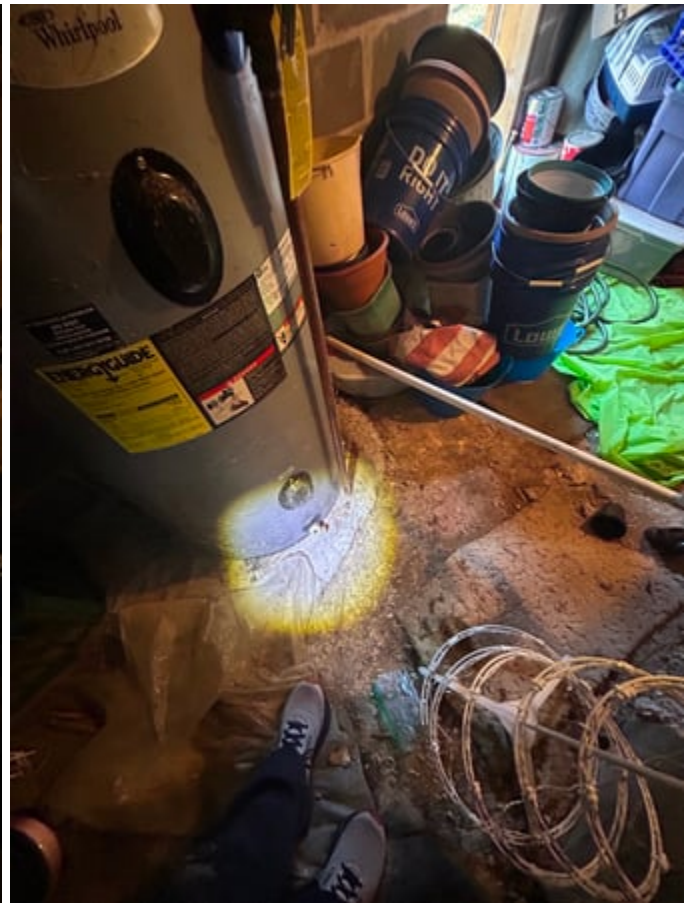
Water Heating Equipment (including the energy source, venting connections, temperature/pressure-relief (TPR) valves, Watts 210 valves, and seismic bracing)

No Defect(s) Observed

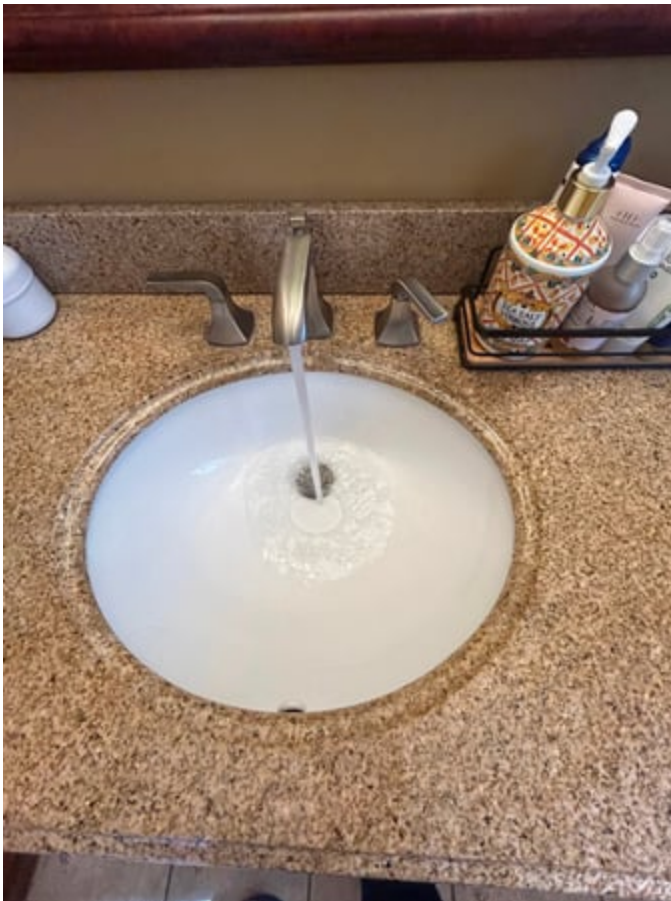
All Sinks, Tubs and Showers (for functional drainage)

No Defect(s) Observed

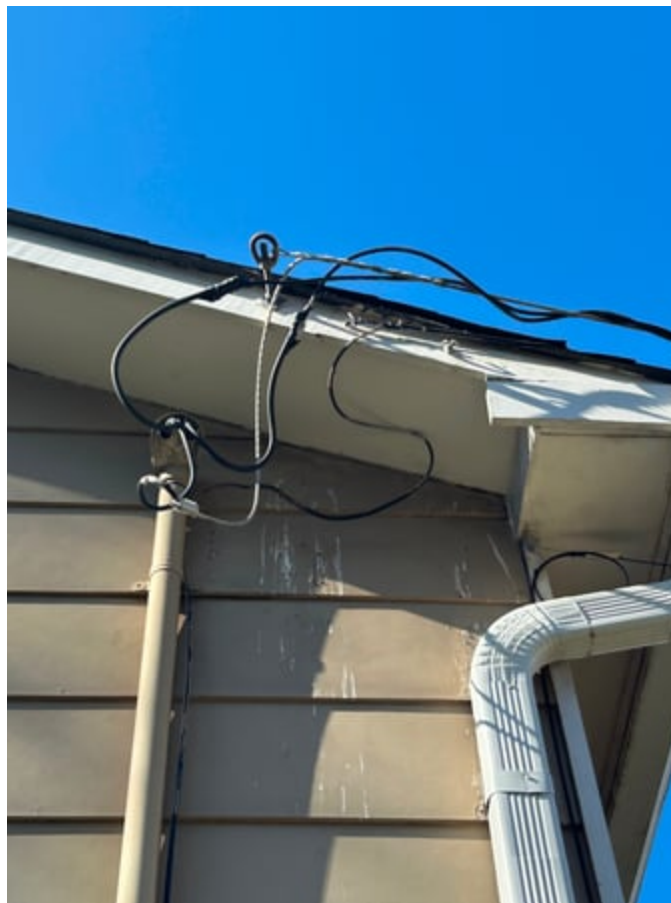
Service Drop

No Defect(s) Observed

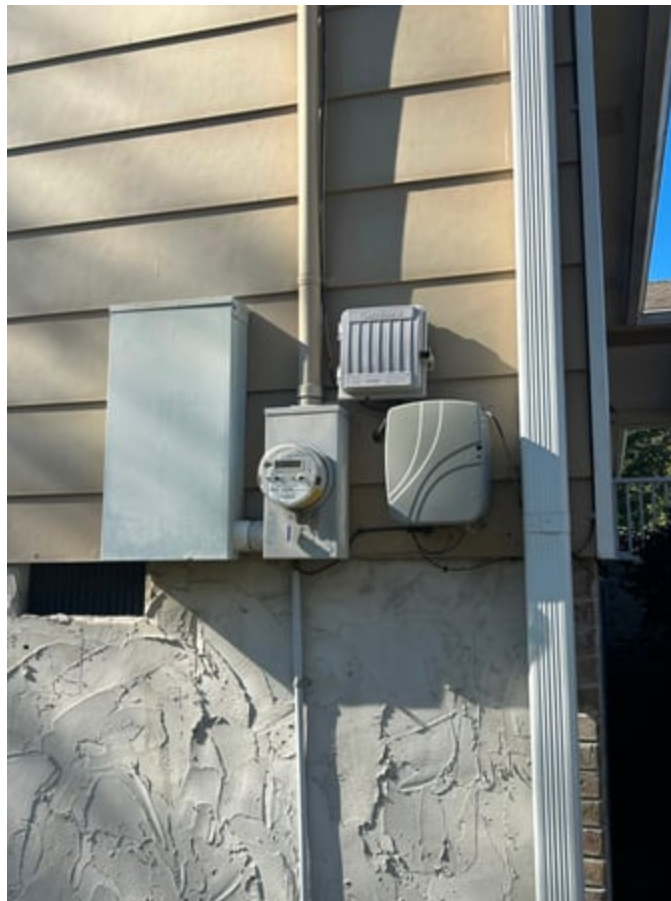
Electric Meter and Base

No Defect(s) Observed

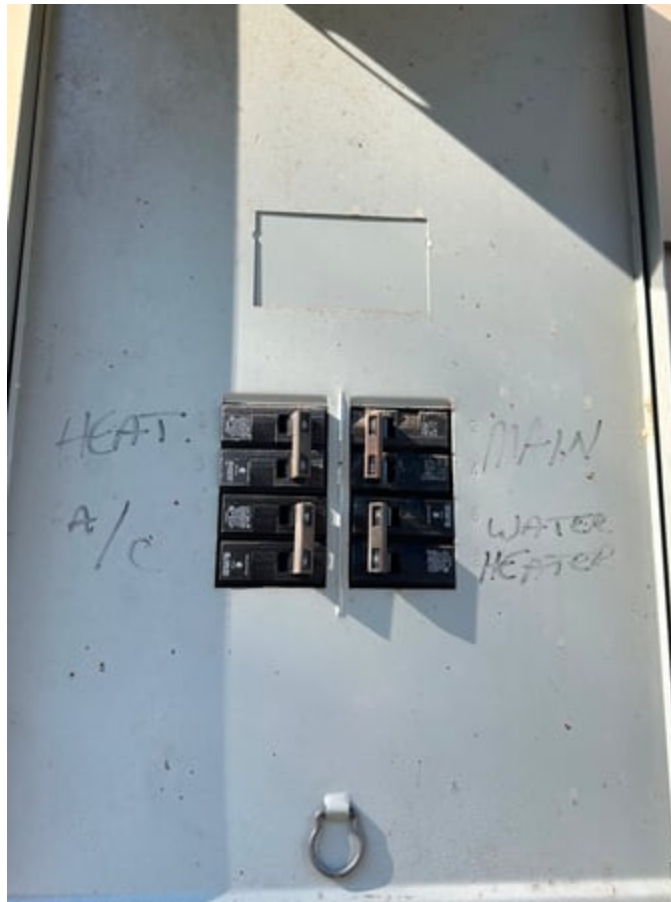
Main Service Disconnect

No Defect(s) Observed

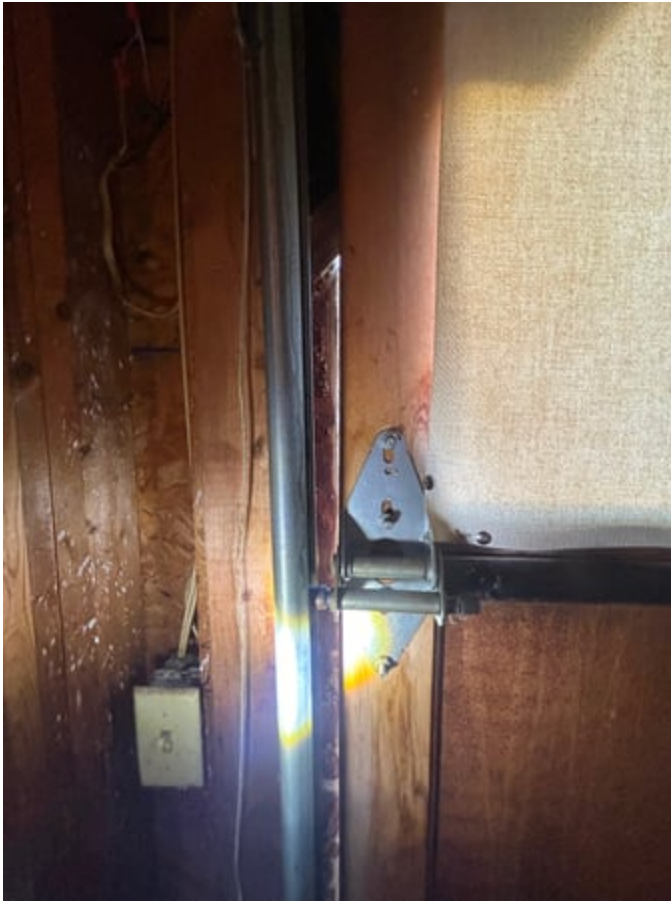
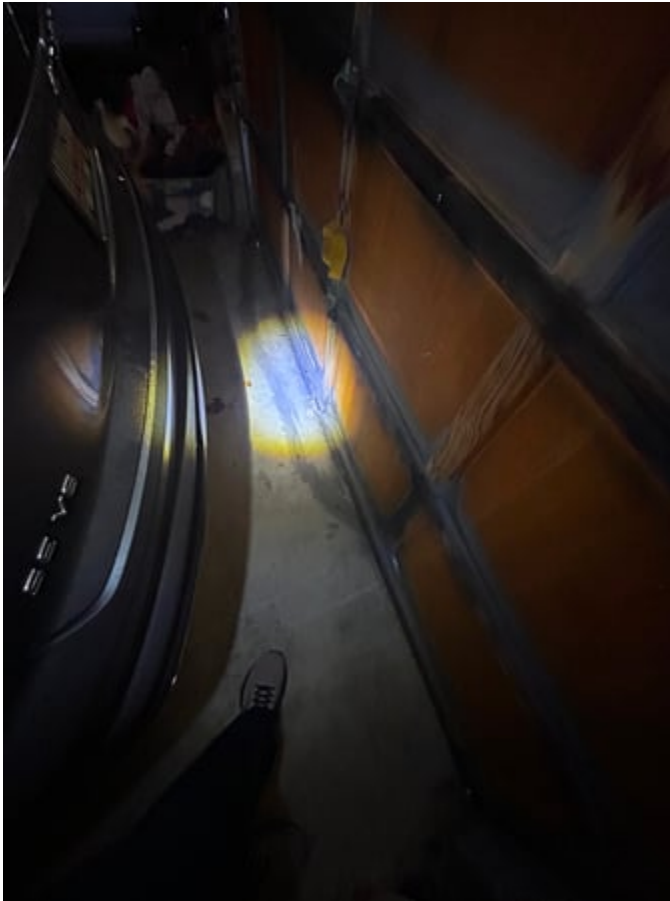
Major Defect

Eye beams were located too high. Door panels showed water damage. Springs did not have cables.
